Failure analysis of a kind of low power connector

ZHOU Yi-lin^{†1}, ZENG Ning¹, XU Liang-jun¹, JÖRGENS Stefan^{†2}

Abstract: A kind of low power connector used e.g. in household appliances was partly burned in routine experiment. The heat sources were four paralleled contacts constructed by springs (Sn/CuSn-alloy) in socket and a plug sheet (Ni/Steel) while mating. The contact interfaces were detected by scanning electronic microscope (SEM) and X-ray energy dispersive spectroscopy (XEDS), obvious wear tracks and various contaminants, including element Si, Al, Na, K, S, Cl, O, etc., were found. The contamination degrees on the four paralleled contacts were different, so that the ratio of average contact resistance on the four contacts was about 5:8:3:1. The maximum contact resistance on contacts of the plug sheet reached 28 Ω . The main failure reasons were fretting and contamination between the contact interfaces. Fretting simulation showed that connection resistance of connectors was raised up, even to ohms level. When the current increased to 5 A, the socket housing was heated and decomposed. By the thermal analysis, it was estimated that the connector would be burned under the

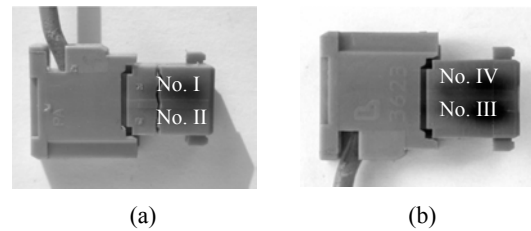
There were obvious burned tracks on the socket housing, as shown in Fig.1. The dark color of the housing indicates that the temperature on the housing reached the thermal decomposition point (310 °C) at least. The surfaces of springs in the socket and the plug sheet are tarnished, as shown in Fig.2. The positions of burned tracks on the housing are consistent with the four contacts, comparing Fig.1 with Fig.2, so

Fig.1 Outside observation of the burned socket housing. (a) The face of the housing; (b) The backside of the housing

that the housing is burned by the heat produced on contacts. It is clear that the color of the two burned tracks at the backside of the housing is similar, shown in Fig.1b. However, the color of No. I burned track is lighter and the No. II is the lightest at the face of the housing, shown in Fig.1a. The burned tracks with different degrees at the housing indicate that the heat produced on the four contacts is not equal.

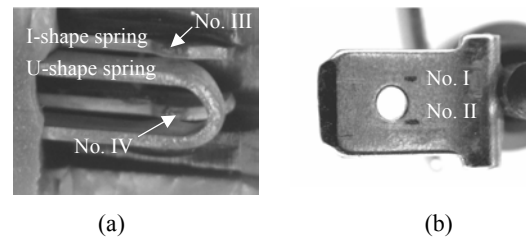
Fig.2 Observation of the contact pairs. (a) The springs in the socket; (b) The face of the mating plug sheet

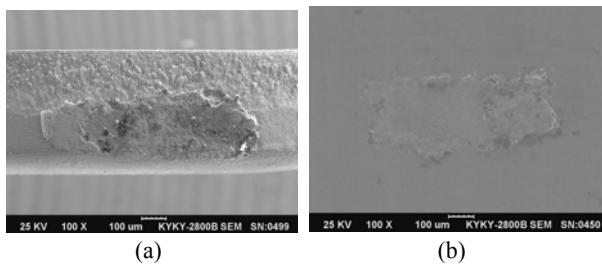
SEM photos of two pairs of contacts, Nos. II and III, are shown in Figs.4 and 5, respectively. No. II contact is formed by the U-shape spring in the socket and the face of the plug sheet, the adjacent housing is burned most lightly. No. III contact is formed by the I-shape spring in the socket and the backside of the plug sheet, the adjacent housing is burned heavily.

Fig.4 No. II contact pair in the burned connector. (a) The contact on the U-shape spring in the socket; (b) The contact on the face of the plug sheet

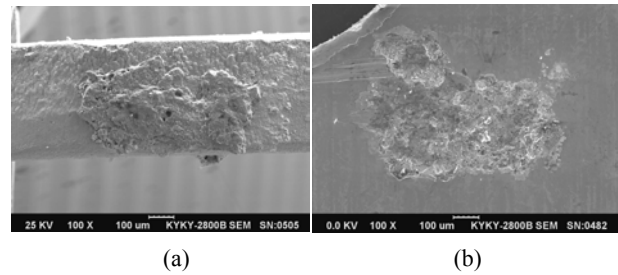
Fig.5 No. III contact pair in the burned connector. (a) The contact on the I-shape spring in the socket; (b) The contact on the backside of the plug sheet

The contacts are not molten and the plastic housing is not decomposed until the current increased to 5 A during fretting simulation. Comparing the sizes of wear zones in failed connector (Fig.5) and those in accelerated experiments (Fig.18), it is shown that the fretting simulation conditions are more rigorous than real working conditions. Therefore, it is not easy for the connectors to fail and burn only under fretting conditions in the applied field, but the fretting degrades the contacts indeed. The unevenly distributed contamination and the fretting on contacts are the main reasons for failure of the low power connectors.

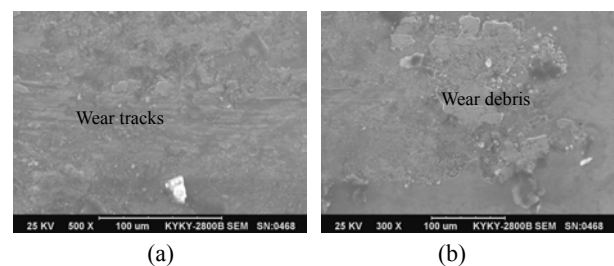
There were obvious wear tracks on the contacts on both the springs in the socket and the plug sheet, shown in Figs.4 and 5. The center of No. I contact on plug sheet is magnified in Fig.6a. The wear tracks appeared to be along the insertion direction of the plug sheet. Wear debris was accumulated on the end of wear tracks, as shown in Fig.6b.

Fig.6 Obvious wear tracks on No. I contact on the plug sheet. (a) Center of the contact; (b) Right part of the contact

The element compositions in the center of wear tracks on the plug sheet were mainly Ni, Fe and a little Sn, Cu, as well as Si, Al. The wear debris was mainly Sn, Cu, O and C. It can be deduced that fretting occurred on the contacts. During fretting, both Sn

and Cu transferred from the springs to the plug sheet, and were oxidized and pushed away to accumulate at the ends of the wear tracks. Ni and Fe on the plug sheet were also worn.

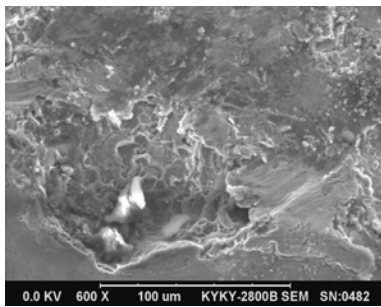
Molten materials could be found on the border of the contact zones on the plug sheet. It could be deduced that the materials of connectors were molten under high temperature, but that the fretting between the contact interfaces occurred at the same time. Therefore the molten phenomena in the center of contacts were covered by the wear tracks, but remained on the border of contact zones, as shown in Fig.7. The main compositions on molten zones are the materials of contacts, Fe, Ni, Cu, Sn and O, C. Obvious molten zones were not found on the No. I and No. II contact pairs.

Fig.7 The molten zone on the border of No. III contact in Fig.5b

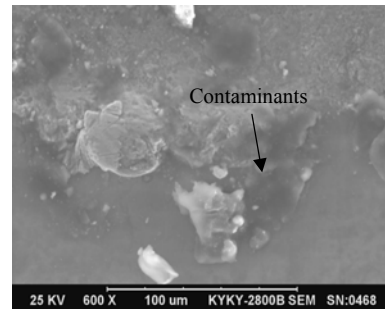
Contamination exists on all the contacts. Since most of the contaminants are insulative, space charges are produced on contaminants under SEM, shown in Fig.8. The element atomic percentage of the contaminants is about C (70.5%), O (25.1%), Na (1.3%), K (0.5%), Si (0.2%), S (0.3%), Cl (1.2%) and Ni (1%). Both morphology and compositions of such kind of contaminants are similar to the galvanic corrosion of contacts in natural environment (Zhou *et al.*, 2000b). The contaminants distribute on the border of contacts, which could also be pushed and accumulated by fretting.

Fig.8 Contaminants on the bottom of No. I contact of the plug sheet

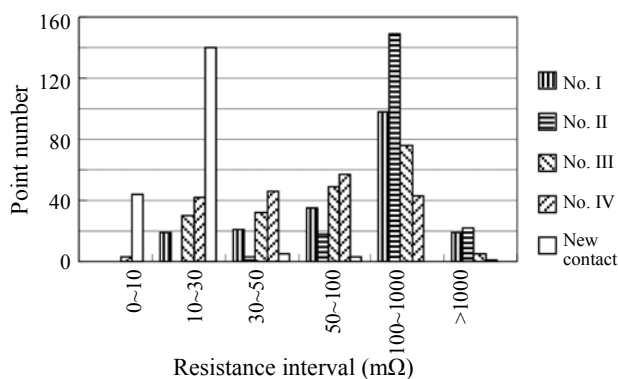
It was clear that the contact resistance on No. II contact on the failed plug sheet was the highest and

**Fig.9 The distribution of contact resistance value of four contacts on the failed plug sheet and a new one**

mainly concentrates in the 100~1000 m Ω range, with the maximum contact resistance reaching 28 Ω . The No. I contact was the second. The contact resistance on Nos. III and IV contacts was a little lower than them. The ratio of the average contact resistance on four contacts was about 5:8:3:1.

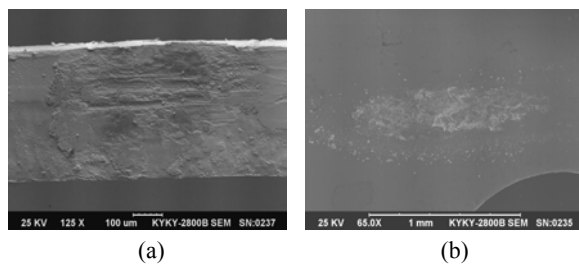
The contacts on the spring in the socket and on the plug sheet after fretting are shown in Figs.13a and 13b respectively. The contact zone, about $700\ \mu\text{m}\times 400\ \mu\text{m}$, was wider than the contacts in the burned socket, which means the wear by fretting is more severe than that in the burned socket. The surface finishes on both the spring contacts (Sn) and the plug sheets (Ni) were worn out, the substrate materials of contact pairs, Cu and Fe, were exposed. At last, the Sn, Ni, Cu and Fe were oxidized to increase the connection resistance. But there was no obvious molten track since the current was too low. Fretting simulations verified that the connection resistance of

Fig.13 Morphology of a contact pair after fretting. (a) The contact on U-shape spring in the socket; (b) The contact on the plug sheet

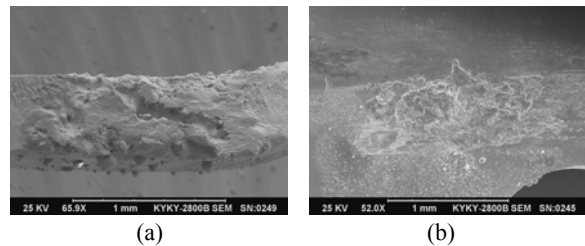
When the current reaches 5 A, obvious molten phenomenon begins to occur on the contacts and the adjacent plastic housing appears to be dark. One pair of contacts under 5 A current after fretting is shown

in Figs. 18a and 18b respectively. Under that condition, the balanced connection resistance of four paralleled contacts was about 0.11 Ω , the produced heat of the connector was 2.75 J in total, about 0.69 J for each contact pair averagely. The production of Joule heat is more than its dissipation in this mating structure of connector. That is the approximately critical failure condition.

Fig. 18 Obvious molten phenomena on one pair of contacts under 5 A current after fretting. (a) The contact on the U-shape spring; (b) The contact on the plug sheet
