Cite this as: Xie-ping Huang, Jing Hu, Xue-dong Zhang, Zi-tao Zhang, Xiang-zhen Kong, 2020. Bending failure of a concrete gravity dam subjected to underwater explosion. *Journal of Zhejiang University-SCIENCE A (Applied Physics & Engineering)*, 21(12):976-991. <https://doi.org/10.1631/jzus.A2000194>

## Bending failure of a concrete gravity dam subjected to underwater explosion

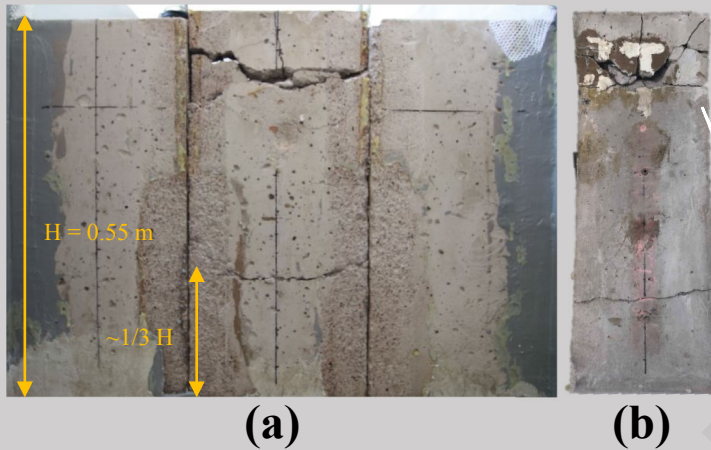
The first fracture in the upper part is at the change in the downstream slope, and is normal to the upstream face.

**Fig. 1 Dam failures from the centrifuge test UE-04: (a) upstream face; (b) downstream face**

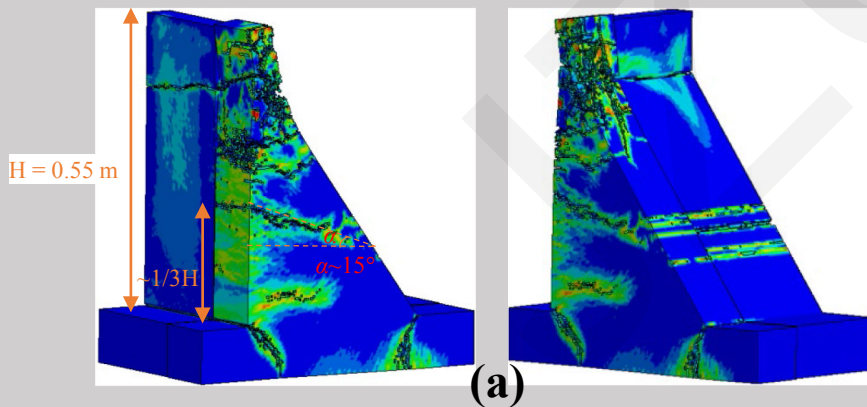
The second fracture is in the lower part at around one third the height of the dam. This fracture is no longer normal to the upstream face, as there is a horizontal angle with a measured value of about  $15^\circ$ .

**Fig. 2 Dam failures from numerical simulations (a) and centrifuge test UE-04 (b)**
