## Particle contamination, the disruption of electronic connectors in the signal transmission system<sup>\*</sup>

ZHANG Ji-gao

(Research Lab of Electric Contacts, Beijing University of Posts & Telecommunications, Beijing 100876, China)

**Abstract:** Particle pollution in air, also sometimes known as fine dust contamination, may cause electric contact failure. Recent research further proved that the fine particle is becoming a major disruption of the electronic connectors in signal transmission system. This paper specifies the connector contact in mobile phone application. To study the contact failure of mobile phone, a series of inspections and analytical research methods are introduced. Special features that cause the contact failure are summarized. Particle accumulation is the main problem; organic material such as lactates from sweat of the human body may act as adhesives to stick the separate particles together and make them adhere on the contact surface; chemical properties of dust cause serious local corrosion. The corrosion products may trap the particles and firmly attach on the contact surface; micro motion frequently occurs at the contact interface. Hard particle can b

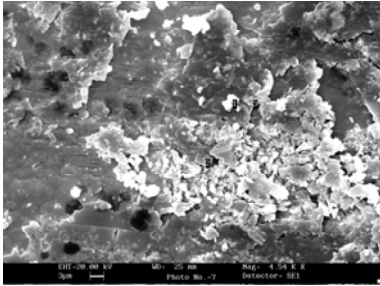
revealed that the contacts were contaminated by various materials of different sizes accumulated in them. Fig.1 illustrates a typical failed contact of a mobile phone whose life is only 3 months. At the testing points 1, 2, 3, certain amount of Si which is one of the main elements in dust, was found in the contaminant of the contact.

**Fig.1 Accumulated particles on failed contact surface (covered with thin Au)**

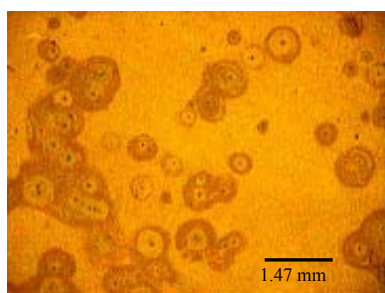
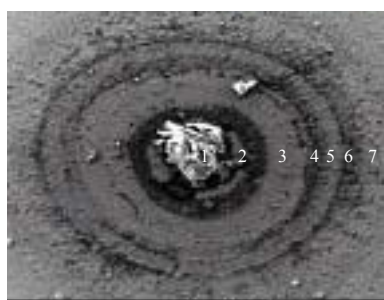
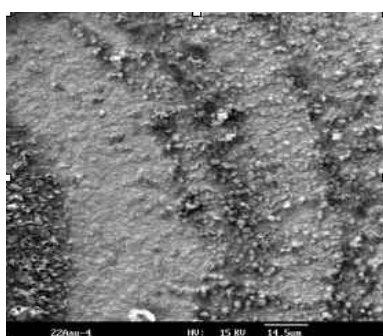
Fig.3a shows the corrosion stain on gold plated sample after 22 months of exposure indoor in Shanghai (taken by optical microscope). Fig.3b shows the morphology of a corrosion stain (taken by scanning electron microscope (SEM)). In the stain, where a core is located at the center, surrounding by several rings. Fig.3c shows the ring formed by numerous islands (Zhang *et al.*, 2000).

**Fig.3 (a) Gold plated sample after 22 months of exposure; (b) Morphology of a stain (SEM); (c) Corrosion ring formed by numerous islands (SEM)**

ments of Ni, Cu, S, O, and Cl. By further studying under electron spectroscopy for chemical analysis (ESCA), the compounds were identified as sulfates, chlorides and oxides of nickel and copper. The result shows that Si and Ca are elements commonly found in dust.

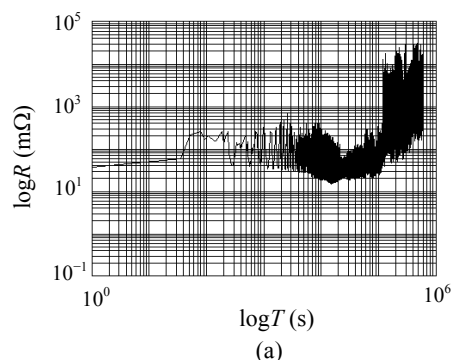
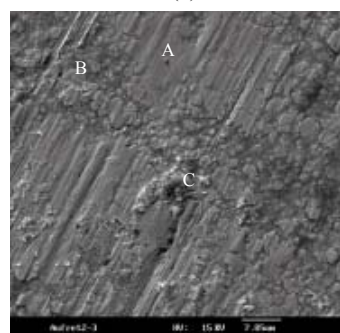
Periodically sliding the above corroded sample and testing contact resistance (normal force 50 g, sliding distance 30  $\mu\text{m}$ ) with a micro motion apparatus, contact resistance was kept at a very low rate. This fact shows that the corrosion products are crashed and worn out as debris but that metallic contact was still made. However, when the rider passes across the ring after certain number of cycles, contact resistance became a very high value as shown in Fig.4a. SEM/XES inspection on the surface, a silicon particle (probably quartz) with about 5  $\mu\text{m}$  is embedded on the surface that causes high resistance as illustrated in Fig.4b.

**Fig.4 (a) Micro motion on corroded sample. Vertical scale illustrates contact resistance ( $\text{m}\Omega$ , in log), horizontal scale shows time (s, in log; 300 s per sliding cycle); (b) Spot C is the embedded particle. Spots A and B are corrosion products**

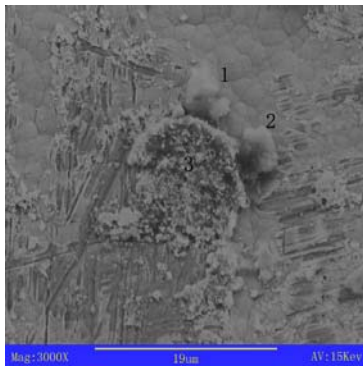
XES inspection reveals that the contaminants include a mixture of dust particles, wear debris of corrosion products as well as wear particles of nickel and copper and their oxides (Feng *et al.*, 2005). Many of these contaminants are accumulated at the end of wear tracks or the vicinity areas as illustrated in Fig.5. In Fig.5, both Si and Ca are found at 3 testing spots.

**Fig.5** Accumulated particles located at the end or beside the sliding track. Grey color indicates Ni plating and bright color indicates Au plating

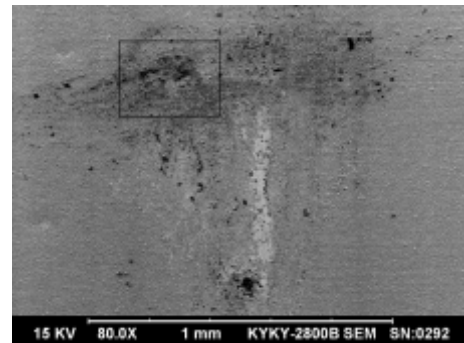
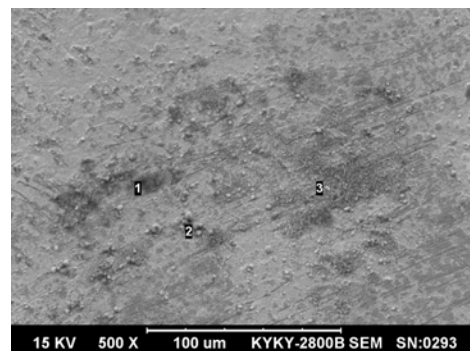
In order to identify the organic materials covered on the contacts, the contaminants of 8 failed contact surfaces are taken and studied under precision infrared spectrometry. The result shows that 6 of them are lactates that are mainly sodium lactate mixed with calcium lactate and perhaps amino acid (Zhang *et al.*, 2006). The signals received from the other two samples were rather weak, but seem to be the same as that of the majority of samples. Fig.6 shows contaminants on the failed contact surface taken by SEM. High concentration of C was tested under XES.

**Fig.6** (a) Contaminant 80×; (b) Contaminant in the square, 500×

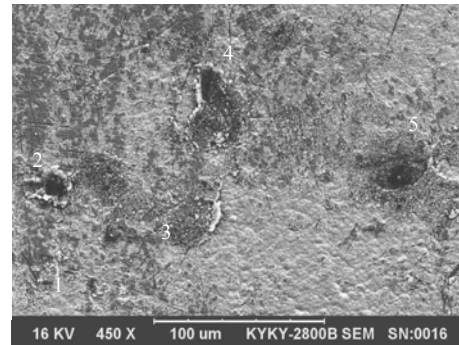
At the failed contact surface more than one high resistance region can be found. At that region, elements of dust especially Si is tested. Fig.8 illustrates

a failed contact surface with several accumulated contaminants. High resistance was found at 10 testing spots. One testing spot had a resistance value of more than 3  $\Omega$ . Table 5 shows the elements on several testing spots.

Fig.8 Contaminants on the failed contact surface
