**Seismic response study on a multi-span  
cable-stayed bridge scale model under  
multi-support excitations.  
Part I: shaking table tests**

**Cite this as:** Zhou-hong ZONG, Rui ZHOU, Xue-yang HUANG, Zhang-hua XIA, 2014. Seismic response study on a multi-span cable-stayed bridge scale model under multi-support excitations. Part I: shaking table tests. *Journal of Zhejiang University-SCIENCE A (Applied Physics & Engineering)*, 15(5):351-363.  
[doi:10.1631/jzus.A1300339 ]

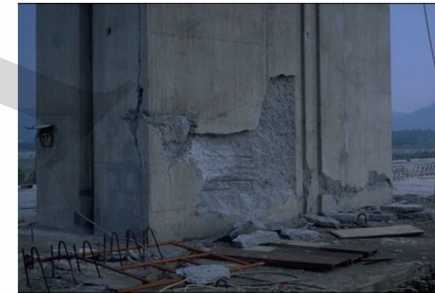
Stripping of Tower

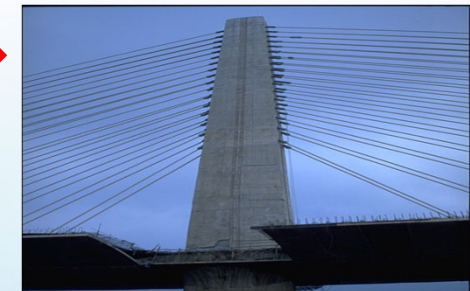
Rockfall of girder

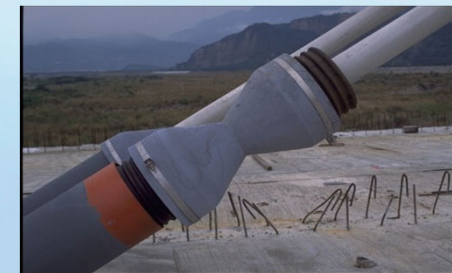
Retrench of cable

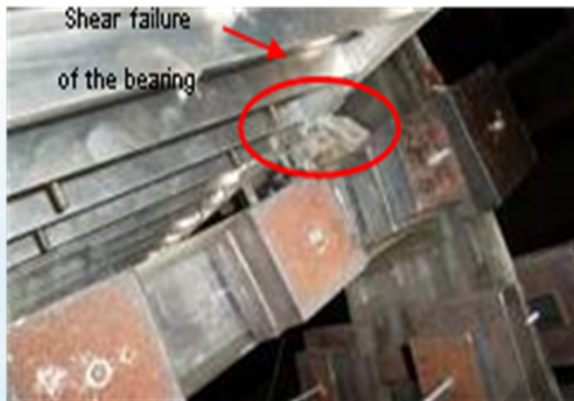
Shear failure of bearing at middle tower

- ▽ Seismic responses of the main girder and towers for the scale model were most evident under Jiangxin (JX) wave among for uniform excitations
- ▽ Seismic performance of the main girder and towers for the scale model were adversely affected by traveling wave effects
- ▽ Shear failure of the bearing of the middle tower first appeared when subjected to the strong excitation
