# Meso-scale corrosion expansion cracking of ribbed reinforced concrete based on a 3D random aggregate model

Zhi-qiang Zhang, Yong-long Li, Xing-yu Zhu, Xin-hua Liu

Cite this as: Zhi-qiang Zhang, Yong-long Li, Xing-yu Zhu, Xin-hua Liu, 2021. Meso-scale corrosion expansion cracking of ribbed reinforced concrete based on a 3D random aggregate model. *Journal of Zhejiang University-SCIENCE A (Applied Physics & Engineering)*, 22(11):924-940.

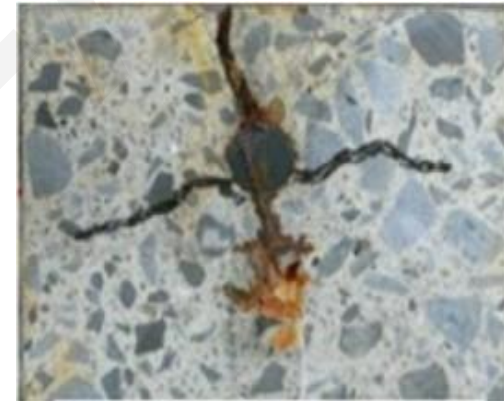
Scenario of a Single Rebar

Reinforced concrete structures will naturally rust and expand in volume causing structural cracking. The purpose of this paper is to discover the law of corrosion expansion in order to improve the durability of the structure.

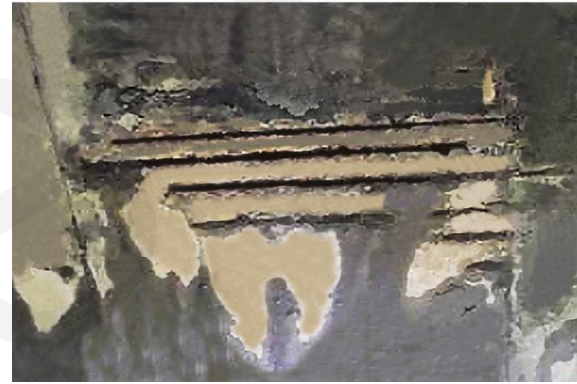
(a) Spalling

- ◆ In the case of multiple rebars, the concrete cover will be spalled when the spacing between the steel bars is small, and wedge-shaped peeling will occur when the spacing is large.
