A method for support stiffness failure identification in a steel spring floating slab track of urban railway: a case study in China

■ Background

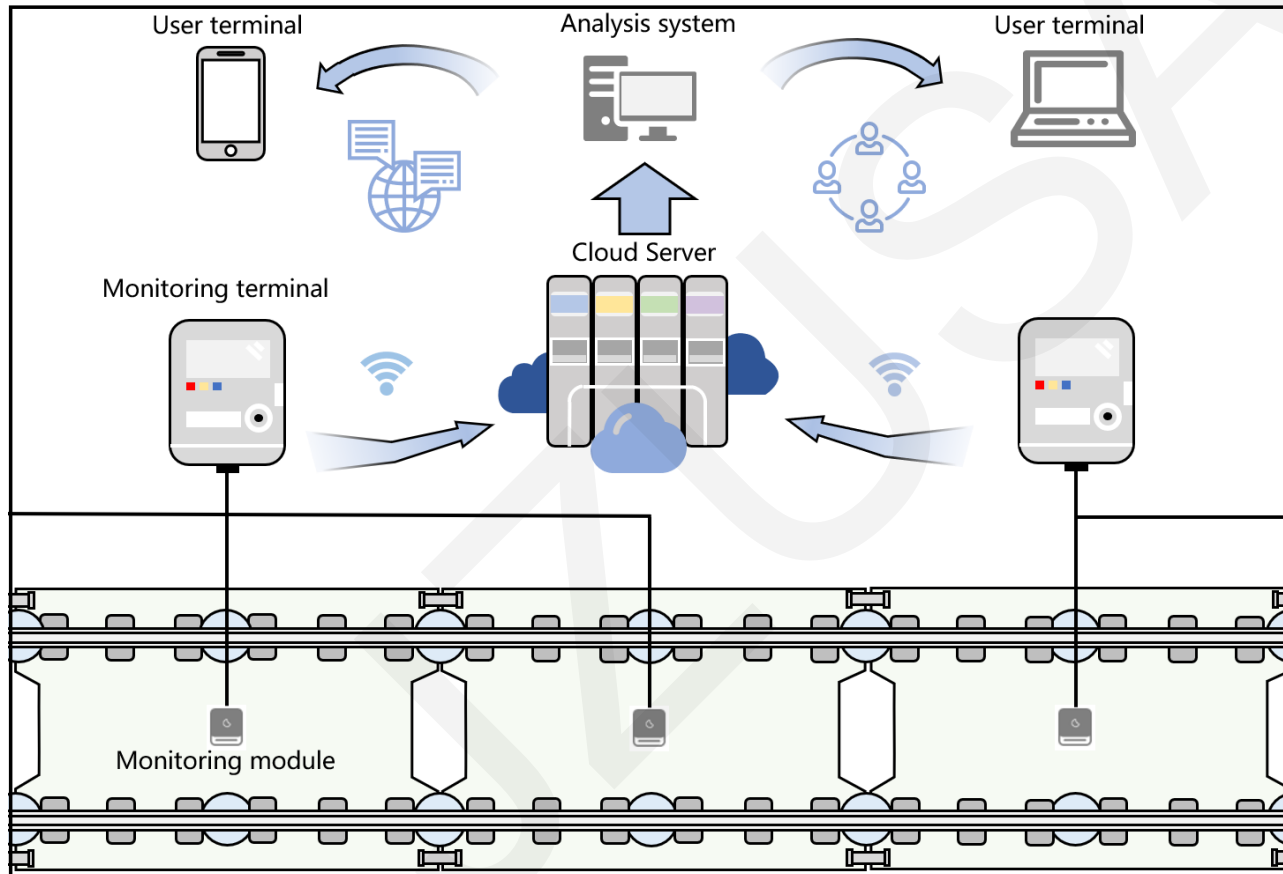
ISFST include monitoring module, monitoring terminal, cloud server, analysis system

Architecture of ISFST

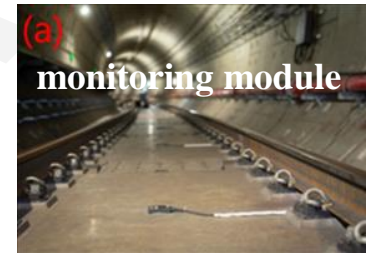
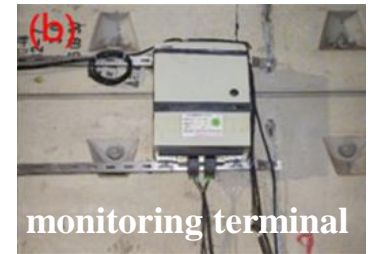
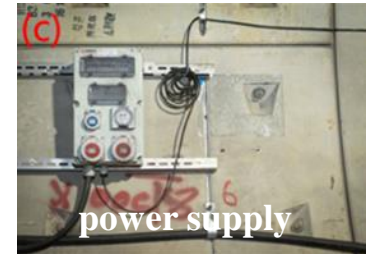
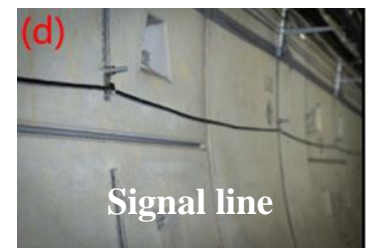
ISFST shows that the natural vibration frequency of the 4th floating slab is significantly lower than that of other floating slabs. This means that the spring is suspended, which is consistent with the on-site investigation.

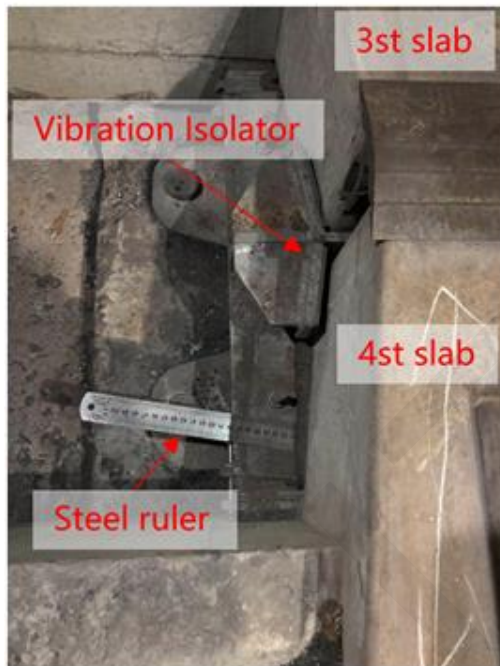
On-site confirmation of steel spring hoisting

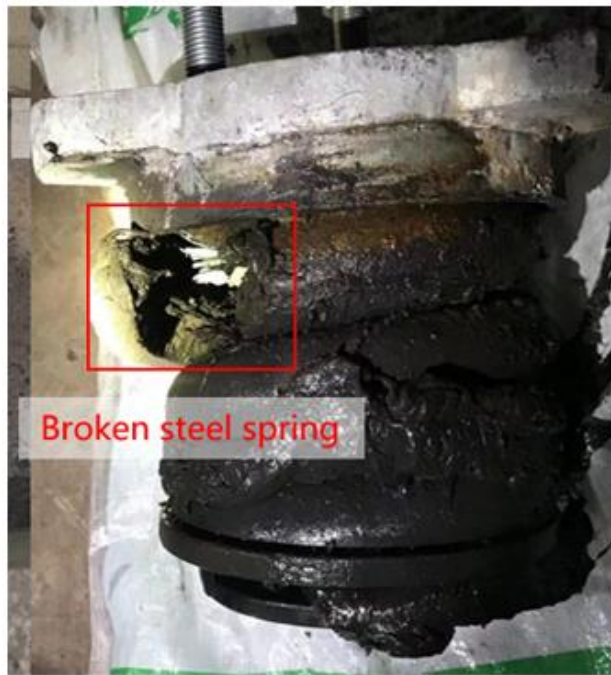
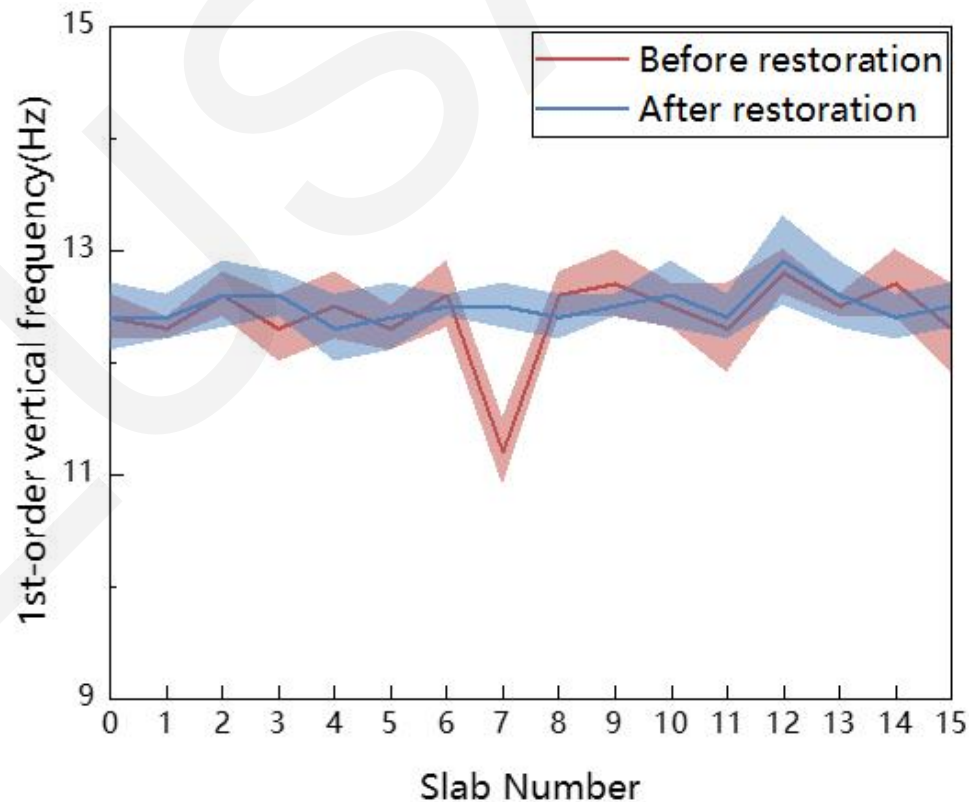
The natural vibration frequency of the No. 7 floating slab is low, and the displacement is a little large. We infer that the steel spring has broken, and the on-site investigation and speculation are consistent.

On-site confirmation of steel spring fracture
