Meso-scale corrosion expansion cracking of ribbed reinforced concrete based on a 3D random aggregate model

Zhi-qiang Zhang, Yong-long Li, Xing-yu Zhu, Xin-hua Liu

Cite this as: Zhi-qiang Zhang, Yong-long Li, Xing-yu Zhu, Xin-hua Liu, 2021. Meso-scale corrosion expansion cracking of ribbed reinforced concrete based on a 3D random aggregate model. *Journal of Zhejiang University-SCIENCE A (Applied Physics & Engineering)*, 22(11):924-940.

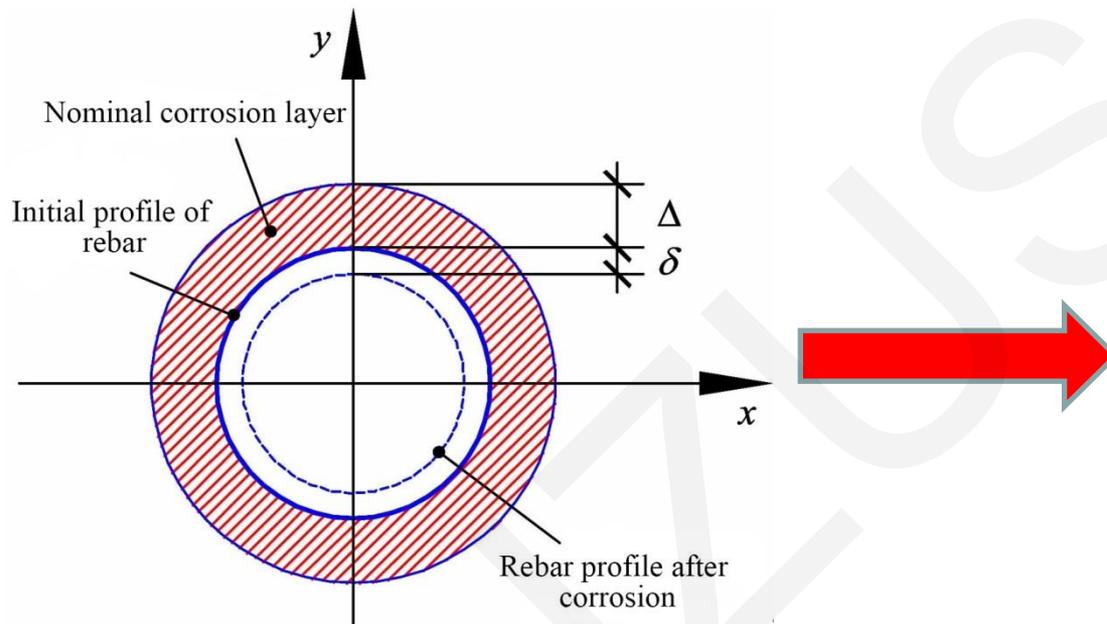
Section of the corroded rebar

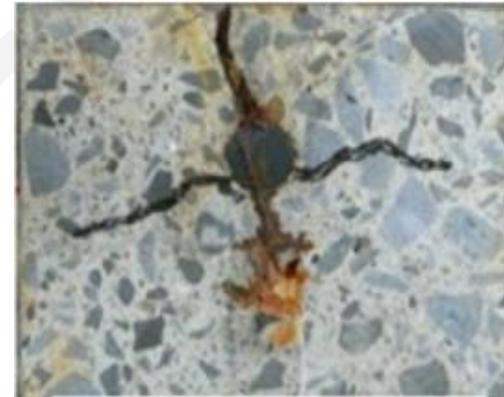
Scenario of a Single Rebar

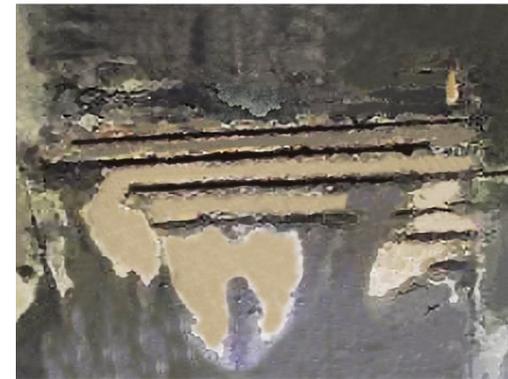
Scenario of Multiple Rebars

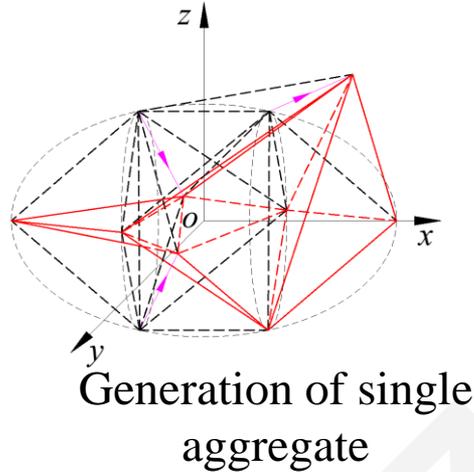
Generation and placement
of aggregate inventory

This paper established a 3D Meso-scale model based on the secondary development of ABAQUS to analyze the crack pattern and the number of destroyed element of the structure and so on under different working conditions of single and multiple reinforcement cases.

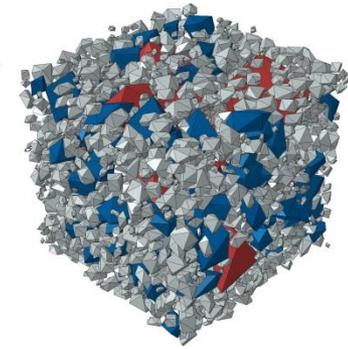
3D Meso-scale model

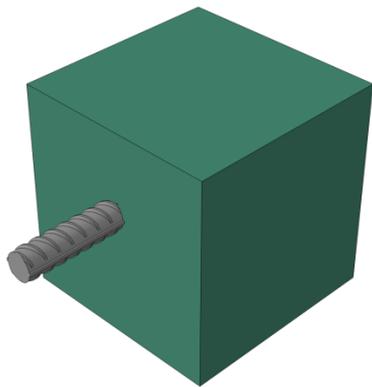
Working conditions

- Concrete thickness;
- Arrangement of rebars

Finite element model

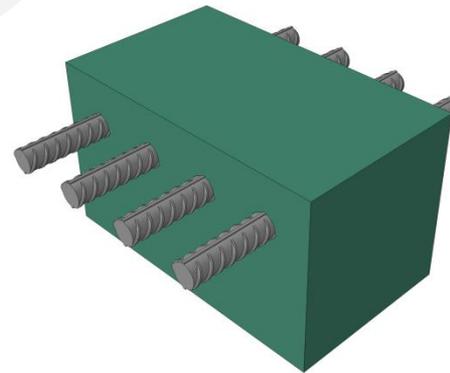
Working conditions

- Rebar spacing

Finite element model

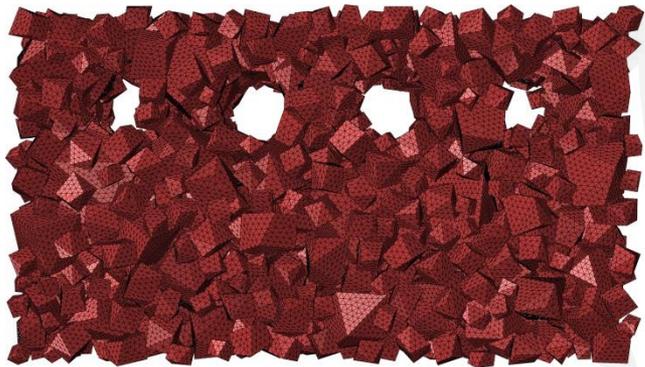
ITZ

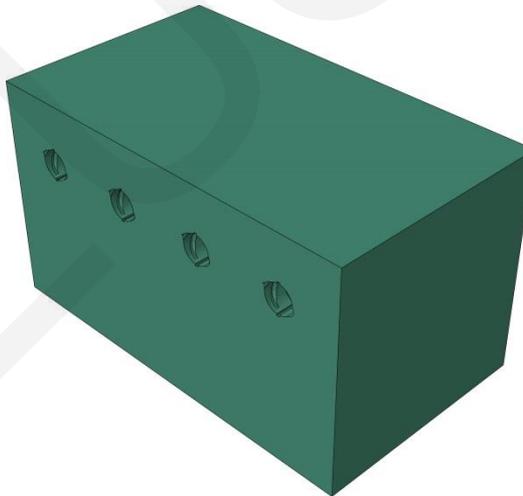
Mortar

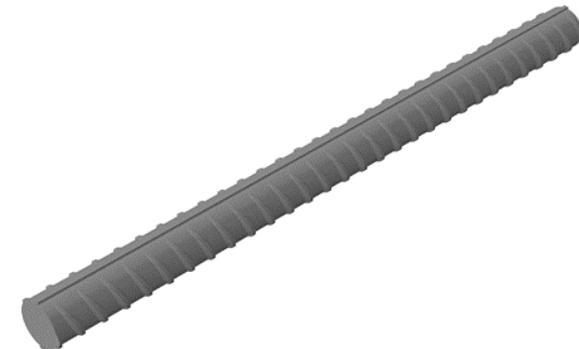
Ribbed rebar

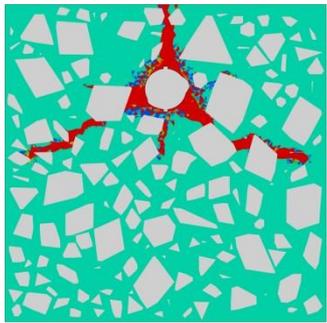
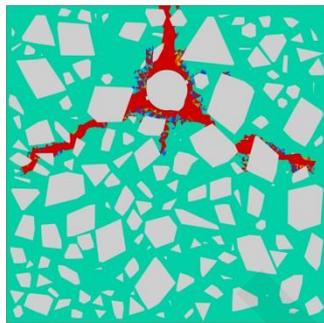
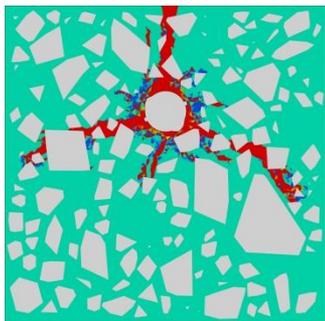
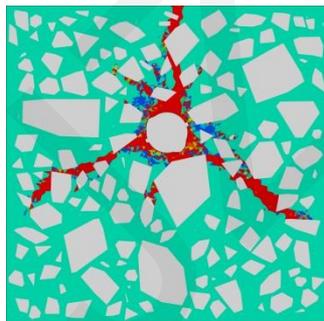
- ◆ The overall pattern of cracks caused by corrosion expansion cracking of rebars was cross-shaped, with a slightly shorter lower limb.

(a) 20mm

(b) 30mm

(c) 40mm

(d) 50mm

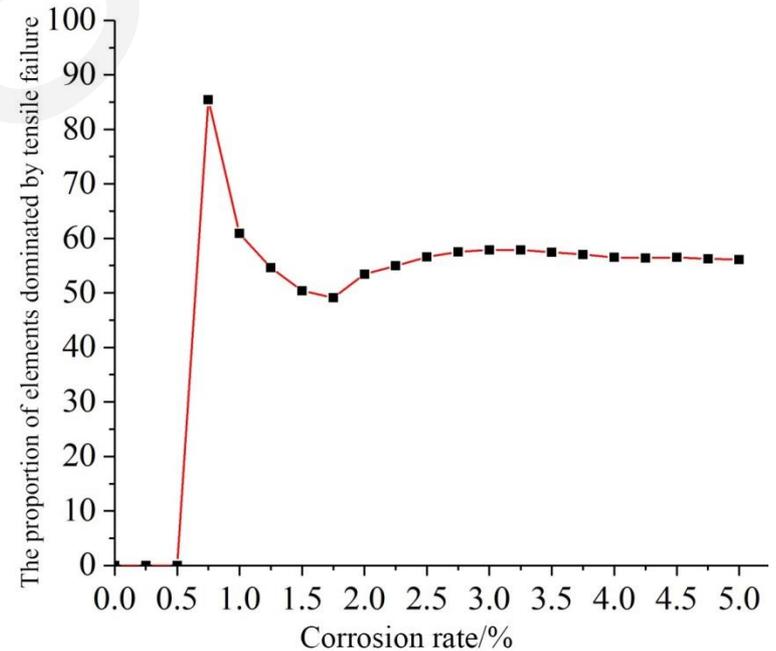
- ◆ No ITZ elements were completely destroyed when the corrosion rate was low. with the further increase of the corrosion rate, the proportion of ITZ elements dominated by tensile failure increase first, and then falls, and then rises to stabilize.

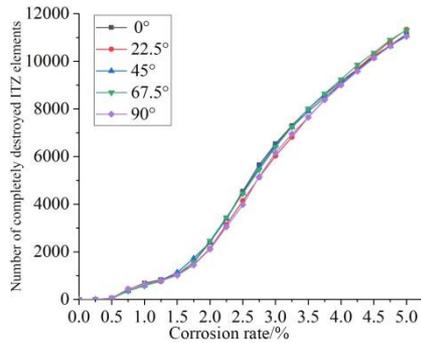
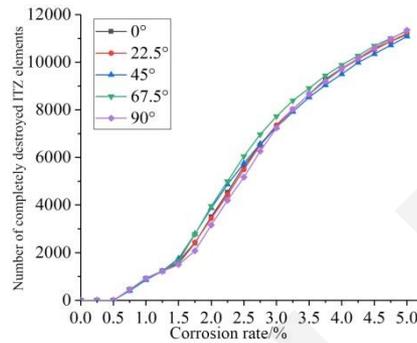
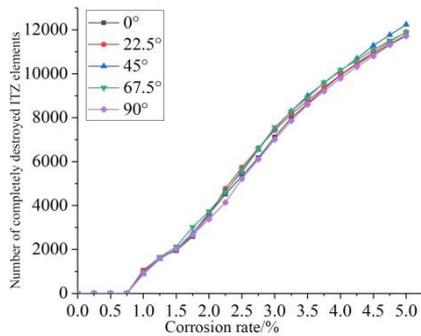
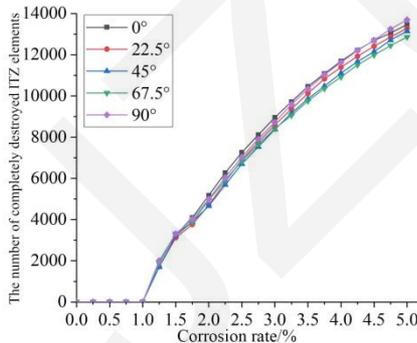
- ◆ With the increasing of the cover thickness, the corrosion rate for ITZ elements that was completely destroyed for the first time

(a) 20mm

(b) 30mm

(c) 40mm

(d) 50mm

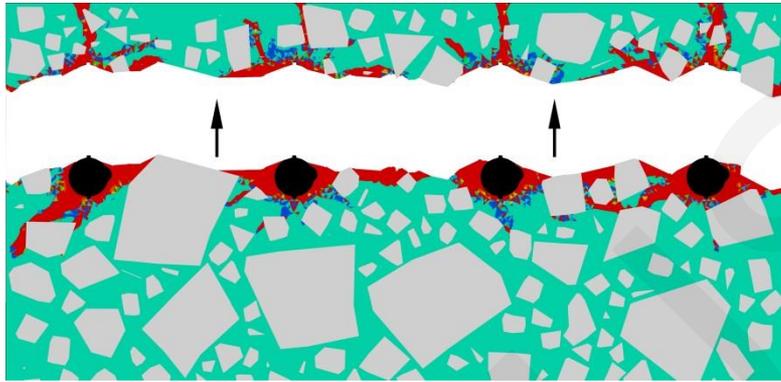
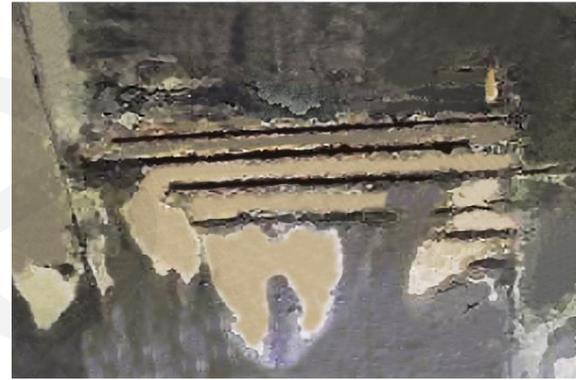
- ◆ In the case of multiple rebars, the concrete cover will be spalled when the spacing between the steel bars is small, and wedge-shaped peeling will occur when the spacing is large.

(a) Spalling

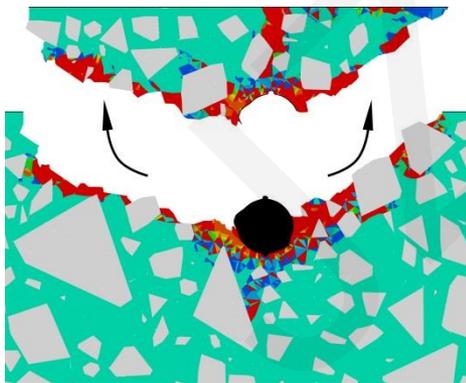
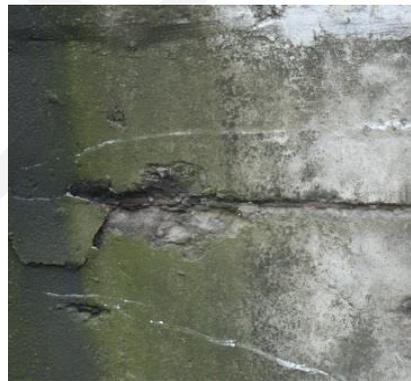
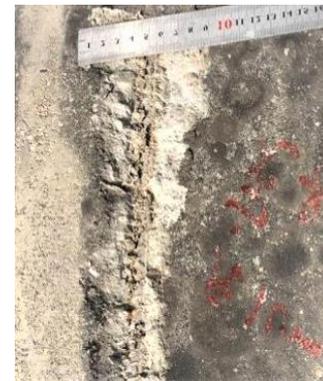
(b) Wedge-shaped peeling
