## Excavation-induced microseismicity: microseismic monitoring and numerical simulation\*

**Abstract:** The volume of influence of excavation at the right bank slope of Dagangshan Hydropower Station, southwest China, is essentially determined from microseismic monitoring, numerical modeling and conventional measurements as well as in situ observations. Microseismic monitoring is a new application technique for investigating microcrackings in rock slopes. A microseismic monitoring network has been systematically used to monitor rock masses unloading relaxation due to continuous excavation of rock slope and stress redistribution caused by dam impoundment later on, and to identify and delineate the potential slippage regions since May, 2010. An important database of seismic source locations is available. The analysis of microseismic events showed a particular tempo-spatial distribution. Seismic events predominantly occurred around the upstream slope of 1180 m elevation, especially focusing on the hanging wall of fault XL316-1. Such phenomenon was interpreted by numerical modeling using RFP-A-SRM code (realistic failure process analysis-strength reduction method). By comparing microse

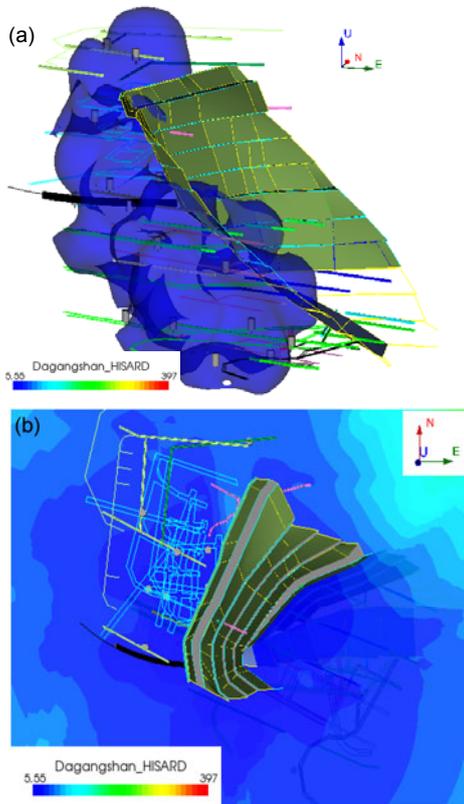
**Fig. 4** Location error analysis after optimal arrangement of sensors from a whole perspective (a) and north-easting plane looking down at 1135 m level (b). Different colors represent various seismic source location errors, the darker the color, the larger the error (Xu et al., 2010b)

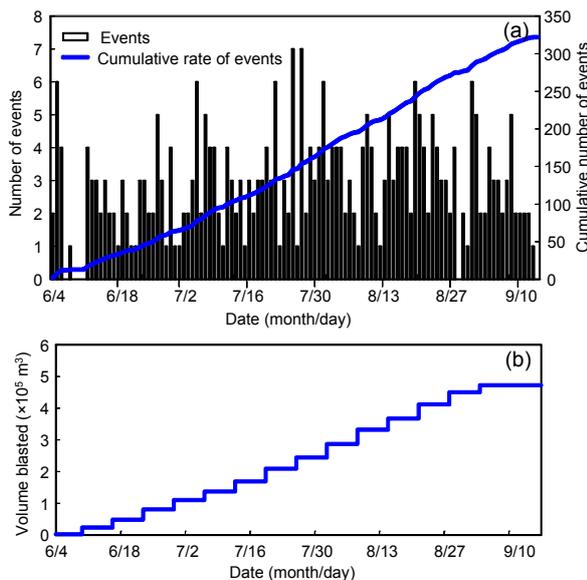
**Fig. 6** Graph of the cumulative number of microseismic events (a), and the curve of cumulative amount of rock mass removed from the right bank slope in chronological order (b). The general forms of the two graphs are similar (in 2010)

the selected time shows one period of increased microseismic activity: July 20 to Aug. 5, 2010. This graph is compared with the time history of excavated rock mass at the bottom of the right bank slope as shown in Fig. 6. It shows that the curve of cumulative seismic events in Fig. 6a has almost the same tendency as the curve of excavated volume of rock mass (volume blasted) in Fig. 6b. This is a good correlation which illustrates a clear consistency between the volume of rock mass being excavated and the total number of seismic events. Therefore, it can be noted that excavation activities play a great role on the levels of extension fracturing within a rock slope—the deeper the slope is, the more stressed and therefore the more it fractures after being unloaded. Seismic data recorded here confirm this link, and go further by providing routine microseismic monitoring to quantify the effects that excavation is having on the slope.

Additionally, Fig. 6a shows that the daily rate of seismic event ranges from one to seven with small bursts of activity per 5–7 d. The mean rate of events during the selected period is three per day. According to on-site investigation, swarms of microseismic events are caused by excavation-induced stress redistribution of rock masses inside the rock slope. Fig. 7 shows temporal distribution of moment mag-

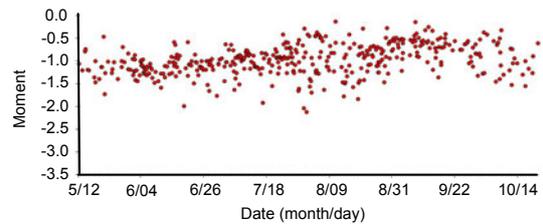
**Fig. 7** Temporal distribution of moment magnitude of microseismic events recorded during the selected period (2010)

nitude of microseismic events during the selected period. It shows that moment magnitude of seismic events is distributed around  $-1.2$ , which is apparently demonstrated in Fig. 8. Moreover, the frequency magnitude distribution outlines a  $b$ -value of 1.0 as the oblique line shown in Fig. 8.

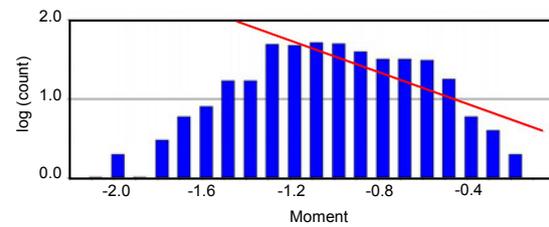
**Fig. 8** Distribution graph of moment magnitude of seismic events

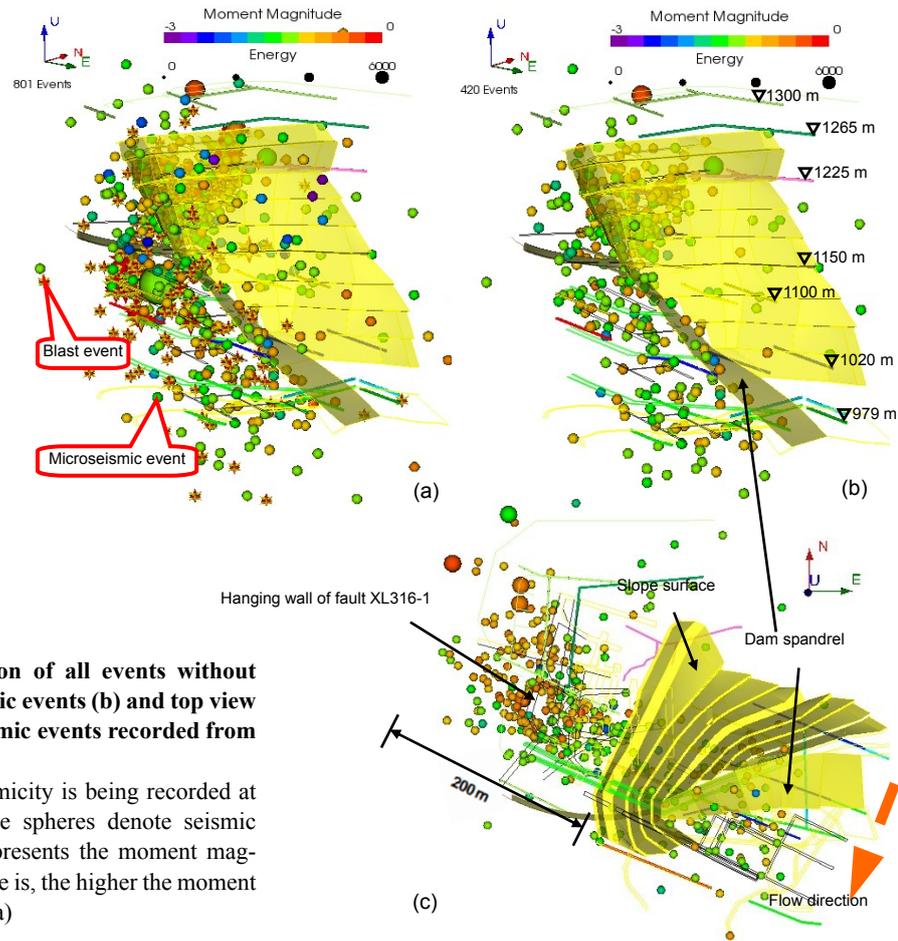
**Fig. 9** Spatial distribution of all events without processing (a), microseismic events (b) and top view from the upside (c) of seismic events recorded from May 12 to Oct. 20, 2010

The spatial distribution of the events recorded during the selected period is shown in Fig. 9. Fig. 9a shows the absolute locations of all events including microseismic events, production blasts and some noises without manual processing. Fig. 9b shows the microseismic events recorded after eliminating interference events. During this period of microseismic monitoring, the rock slope was excavated continuously from the elevation 1070 to 980 m and shearing-resistance tunnels at 1120 and 1150 m elevation were also excavated, respectively. The microseismic events show that hypocenters are concentrated on these excavation zones and this phenomenon is due to the excavation configuration. Fig. 9 shows that seismic source locations follow the working faces and they are located where the excavation is undertaken, making it possible to correlate them unambiguously with the construction areas (Abdul-Wahed *et al.*, 2006). Therefore, the regions inside the right bank slope, where microseismicity is active or inactive, can be identified and delineated.

It is evident that microseismicity is being recorded at significant depths here (the spheres denote seismic source locations, the size presents the moment magnitude. The bigger the sphere is, the higher the moment magnitude is, and vice versa)

In addition, Fig. 9b shows the majority of microseismic events predominantly occurred around the elevation 1180 m of the upstream slope, especially focusing on the hanging wall of the fault XL316-1 (Fig. 9c). The top view in Fig. 9c, looking from the upside, shows that the seismic events are being recorded at significant depths into the slope. However, a small number of seismic events occurred at the bottom of the rock slope. This may be partly attributed to residual movements (e.g., unloading crack zones, developed dikes and faults) inside the rock slope at high elevations and/or the excavation of shear-resistance tunnels. On the other hand, it may be also partly due to high stress concentration at the slope toe because of slope geometry. It is known that seismic activity depends on stresses and tectonic conditions, herein the tectonic stress is probably less important in this zone and the compression stress (normal stress) is higher and helps to reduce the fracturing and the seismic emission. To highlight the relationship

As is known, the excavation of rock slope inevitably leads to stress transfer in the surrounding rock masses, in the form of either stress release or stress accumulation. Microcracking (i.e., AE) may take place in the regions of stress accumulation. The microcracking phenomenon exactly reflects the response of rock slope to stresses, or called the “outcome” of stress field. The numerical modeling used by RPEA-SRM displayed the progressive failure processes of the right bank slope successfully. Thus, the high stress field and high stress difference zones and related AE distribution of the rock slope were obtained. Comparison between Fig. 9c and Fig. 15

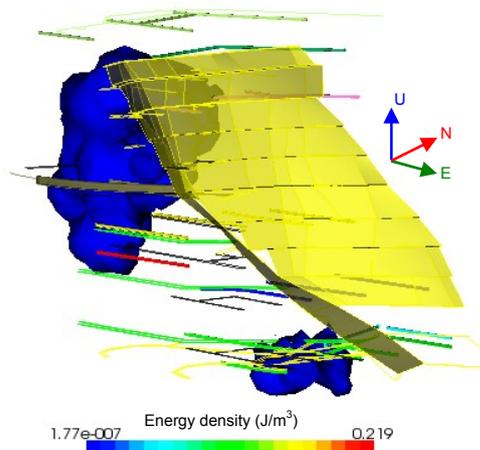
Fig. 11 Density of energy loss induced by microseismic events

Fig. 11 shows the area map of energy loss density induced by microseismicity of the rock slope since the operation of the seismic monitoring system. It can be observed that energy loss of microseismic events induced by excavation is mostly concentrated above the elevation 1135 m of the right bank slope, with an obvious spatial distribution along faults XL316-1 and  $f_{231}$ . A small volume of energy loss by microseismicity occurred at the bottom of the right bank slope. However, the magnitude of energy loss is very small, and the potential impact on the rock slope stability needs a continuous database of seismic source locations for

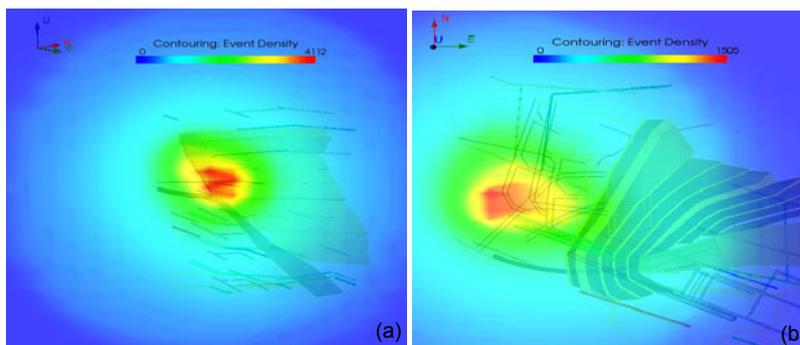
Fig. 10 Seismic source location density contours (number/m<sup>2</sup>) in northeast vertical cross-section looking north-easting (a), and north-easting plane looking down (b). The colors represent various quantities of seismic events per unit volume. The darker the color is, the larger the value of event density

between spatial distribution of microseismic events and the geological structure elements, Fig. 10 shows the density contours of seismic source locations in an aerial view. Note that microseismic events show strong correlation with structure elements on-site, particularly with fault XL316-1.

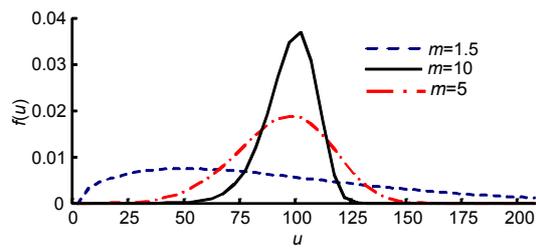
Fig. 13 Curve of different homogeneity index

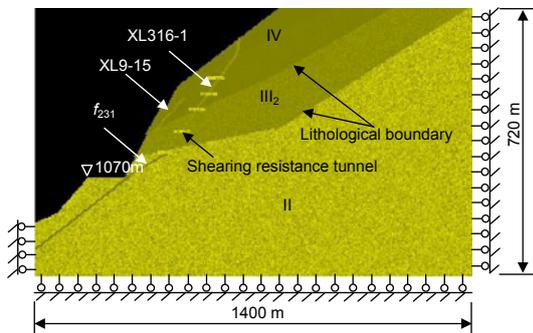
**Fig. 14 Numerical model of transverse section VI–VI of the right bank slope in Dagangshan Hydropower Station, Dadu River, Sichuan Province (the brightness of rock mass denotes the mechanical parameters such as elastic modulus and the magnitude of strength of elements, the brighter the color, the larger the value of the parameters)**

A typical transverse section VI–VI of the right bank slope is obtained (Fig. 2c). The specific geometry and constraint condition for this model are shown in Fig. 14. The numerical domain of the rock slope, modeled by RFPA-SRM, has a dimension of 1400 m×720 m, and is composed of 375×180 (67 500) quadrilateral iso-parametric finite elements. The analysis is carried out under plane strain condition. The rock mass is assumed to be heterogeneous with its mechanical properties defined according to the Weibull distribution, and no heterogeneity is adopted in Poisson’s ratio and internal frictional angle. The coefficient of strength reduction is 0.05 per step. To simplify the calculation model, only main rock masses and faults are considered. The mechanical parameters of different materials are listed in Table 1 (Shao *et al.*, 2009). Note that  $E$  represents elasticity modulus,  $\mu$  means Poisson’s ratio,  $\varphi$  denotes internal friction angle, and  $c$  expresses cohesion.

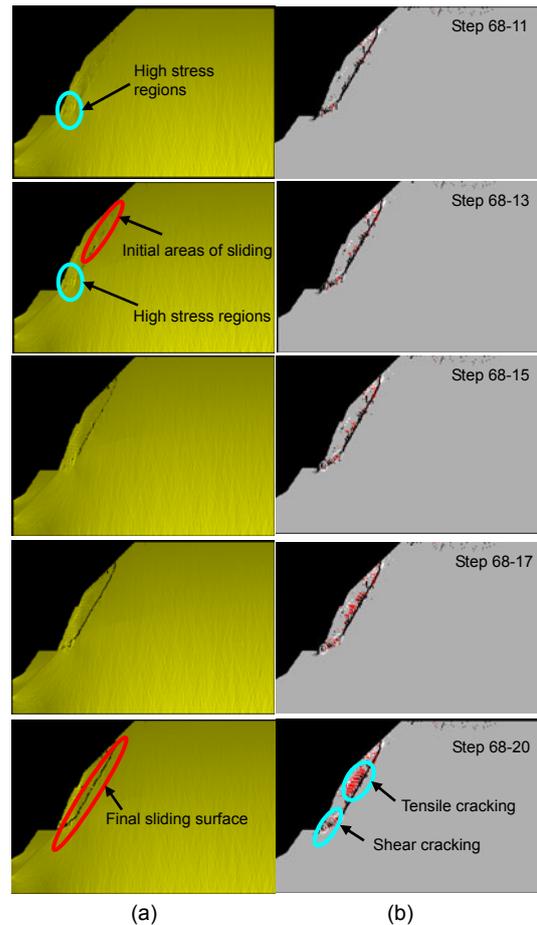
**Fig. 15 Progressive failure processes of the right bank slope based on strength reduction method using the RFPA<sup>2D</sup>. (a) Maximum shear stress; (b) AE distribution**  
The brighter the color is, the higher the shear stress

Fig. 15 demonstrates the progressive failure processes and associated acoustic emission (AE) distribution

distribution of the right bank slope in Dagangshan Hydropower Station. It can be seen that the maximum shear stress firstly occurred at the bottom of the slope (step 68-11 in Fig. 15a) with rock masses strength reduction. In the wake of continuous excavation at the bottom of the slope, sliding deformation at first happens at the top of the rock slope along the hanging

wall of fault XL316-1 (step 68-13 in Fig. 15a), then gradually extends and runs through the bottom from the top of the slope, finally leading to whole instability failure. As shown at the step 68-20 in Fig. 15b, tensile failure focuses on the top of the slope, whilst shear failure concentrates on or near the toe of the slope, accompanying high energy release. As indicated by Griffiths and Kidger (1995), both tensile and shear failures are triggered at the weakest elements, because the strength profile of the rock material is randomly distributed with specified mean and variance. Although under certain stress conditions fractures can occur in the rock mass, pre-existing fractures in the high stress zones in a slope will tend to open up. As the pre-existing joints and fractures in the high stress or stress difference zones open up due to the extension process, fractures would tend to grow into rock bridges causing microseismicity in such zones even if the magnitude of extension is not large enough to cause fresh fracturing in the rock masses (Stacey *et al.*, 2004). These can also interpret why the majority of seismic events recorded during the selected period occurs around 1150 m and higher elevations along with the main faults XL316-1 and  $f_{231}$ , but not near to the excavation faces at the bottom of the right bank slope. If the rock masses strength at the bottom of the slope cannot withstand the high stress induced by production excavation, slippage deformation of fractures will occur along the deep fissure zones from the top of the rock slope. Many microseismic events can be thus induced. The corresponding AE distribution (Fig. 15b) simulated by RFP code shows good correlation with those observed in the spatial distribution of microseismic events (Fig. 9).

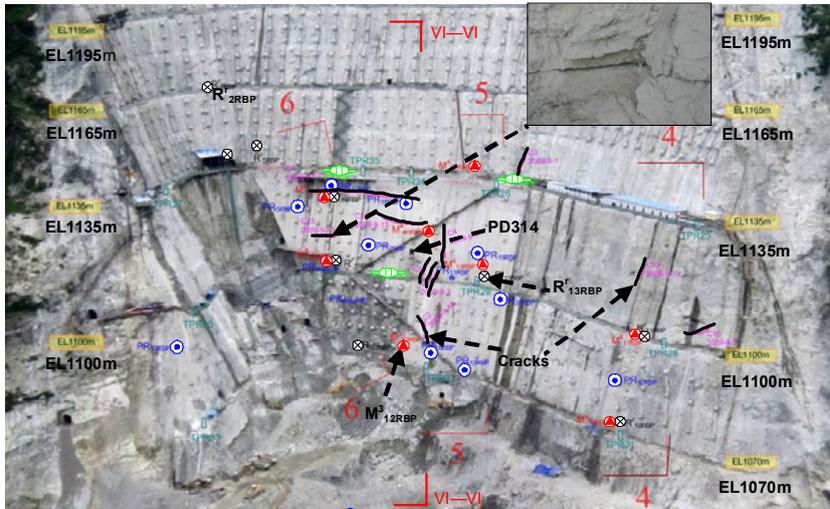
⊗ Bolt stress gauge  
 ▲ Multi-point extensometer  
 ● Anchor stress gauge  
 ⇄ Clinometer  
 — Cracks on the surface of the right bank slope

**Fig. 16** Arrangement of conventional measurements apparatus and cracks distribution at the right bank slope of Dagangshan Hydropower Station

excavation of the rock slope, stress processes graph of anchor stress gauge  $R^1_{13RBP}$  (Fig. 16) at the berm of 1101 m elevation of the right bank slope is shown in Fig. 20. It can partly reflect the stress variance of anchor cable in the deep rock masses of the rock slope. On the contrary, unlike the results of Figs. 17–19, the data of anchor stress gauge  $R^1_{13RBP}$  (Fig. 20) is decreasing during the period from May to August, 2010. This can interpret the high stress release mechanism induced by energy loss of microseismic events inside the rock slope very well. Consequently, microseismic activity can be regarded as the precursor of surface deformation and even instability failure of the rock slope. The evolutionary pattern of stress accumulation, stress releasing and stress migration in the preparation processes of potential instability disaster

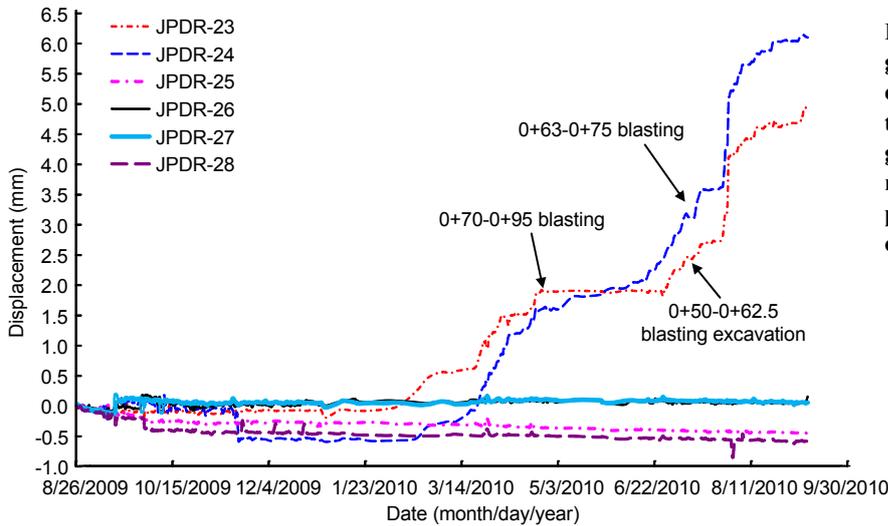
**Fig. 17** Displacement processes graph of surface crackmeter at exploratory heading PD314 of the right bank slope. The growth in data during the period of July, 2010 is a result of production blasts in the process of rock slope excavation

13 are located nearby PD314, Fig. 5). The increase of the graph during the period of July, 2010 is a result of production blasts in the process of rock slope excavation. Fig. 18 shows the displacement processes graph of graphite rod convergence gauge with six points at exploratory heading PD314 of the rock slope. Fig. 19 shows the absolute displacement processes graph of multi-point extensometer  $M^3_{12RBP}$  at dam longitudinal 0+68.5 on the elevation 1075 m of the dam foundation. Compared Figs. 17–19 and Fig. 5, a similar growth trend is obtained during the period of July, 2010, especially at the end of the month. The same change is exactly attributed to production blasts in the processes of excavation of the rock slope according to site observation and construction notes. To study the stress redistribution induced by continuous

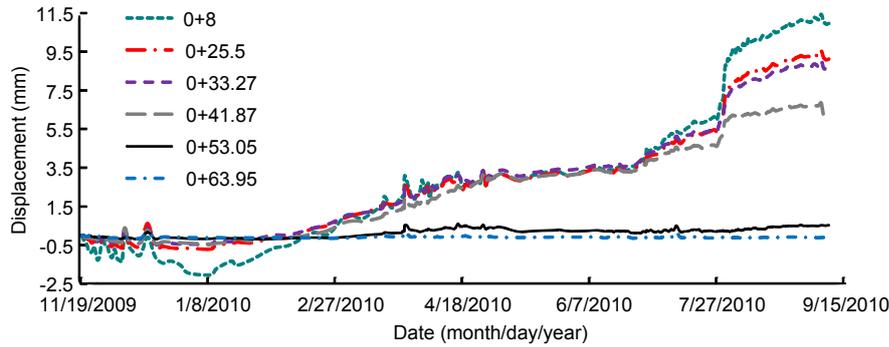
**Fig. 18** Displacement processes graph of graphite rod convergence gauge with six points at exploratory heading PD314 of the right bank slope (the numeral (e.g., 0+8) means the distances away from the adit of PD314)

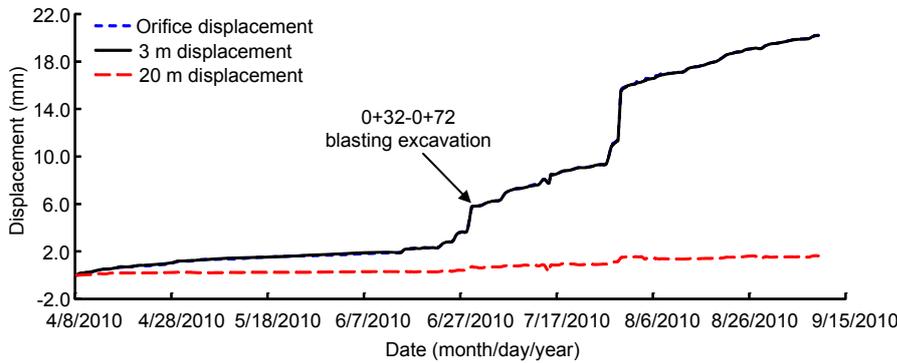
**Fig. 19** Absolute displacement processes graph of multi-point extensometer  $M^3_{12RBP}$  at dam longitudinal 0+68.5 on the elevation 1075 m of the dam foundation

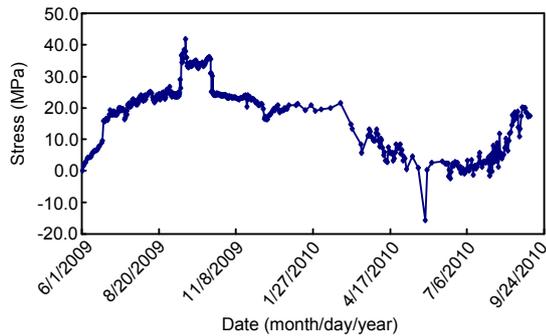
**Fig. 20** Stress processes graph of anchor stress gauge  $R^1_{13RBP}$  at the berm of 1101 m elevation of the right bank slope
