High temperature mechanical performance and micro interfacial adhesive failure of textile reinforced concrete thin-plate*

Abstract: The mechanical performance of textile reinforced concrete (TRC) thin-plate under high temperature conditions was investigated using three-point bending tests. The influence of polypropylene (PP) fiber addition on the out-of-plane load capacity of TRC thin-plate after high temperature treatment was also studied. The results showed that the thermostability of TRC thin-plate with textile impregnated with epoxy resin was not good, but that the out-of-plane load capacity of TRC thin-plate after high temperature treatment could be improved by increasing the plate thickness or the textile distribution rate. Under normal temperature and a high temperature of 120 °C, the out-of-plane load capacity of specimens could be increased and cracks better distributed by mixing the TRC with PP fiber. However, the out-of-plane load capacity of TRC thin-plate under a continuous high temperature of 200 °C was not much affected by the addition of PP fiber. The result of a microcosmic scanning electron microscope (SEM) test showed that the main reason for the interfacial adh

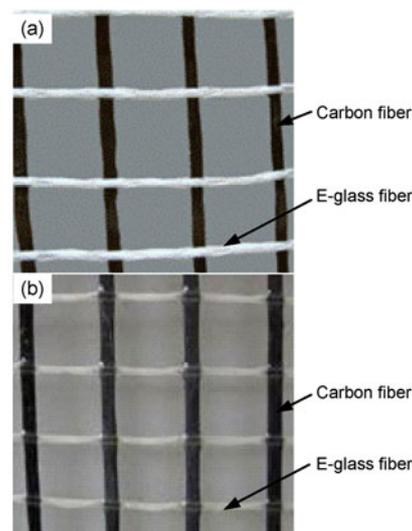
Fig. 1 Carbon/glass woven fiber net
(a) Non-impregnated with the epoxy resin; (b) Impregnated with the epoxy resin

The fiber adopted in this experiment was a 2D woven net made by mixing carbon fiber bundles and E-glass. The two fiber bundles were made of multifilaments which were not twisted, and the meshing size was 10 mm×10 mm (Fig. 1). The mechanical properties of the monofilament fibers are listed in Table 1. The ultimate tensile strength of the glass fiber was lower than that of the carbon fiber, but the cost was higher. Thus, the carbon/glass mixed fiber not only had a reinforcing effect, but also had a better economic efficiency.

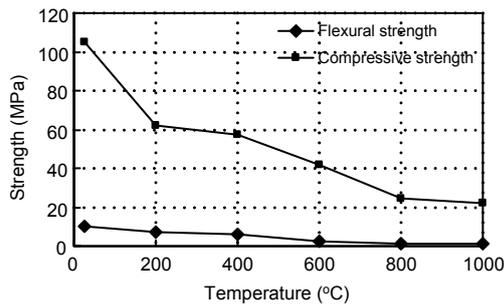
Fig. 2 Influence of temperature on the mechanical properties of fine concrete substrate

The raw material of the fine concrete substrate included Portland cement (PII 52.5R), coal ash, silica fume, water reducing agent (3rd generation of Sika), and sand in the proportions listed in Table 3. Experimental tests showed that the prepared fine concrete satisfied the working performance requirements of self-compacting concrete (Li and Xu, 2006). The influence of temperature on its mechanical properties is shown in Fig. 2.

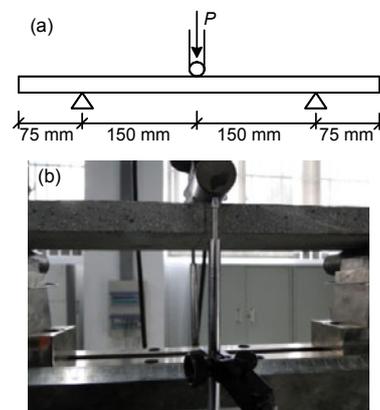
Fig. 3 Three-point bending test (a) Loading schematic diagram; (b) Loading system

The specimens were placed on two pin supports with 300 mm clear span. Experimental tests were conducted with a 250 kN Instron universal testing machine. The loading method is shown in Fig. 3a. The load *P* was measured by a load transducer. The mid-span deflection of the thin plate was measured by two displacement sensors (LVDTs). The loading device is shown in Fig. 3b. Displacement control was adopted in the loading test with a velocity of 0.5 mm/min.

研究方法: 通过三点弯曲试验 (见图 3), 对高温后试件的力学性能 (见图 4、5) 进行测试。通过微观扫描电镜观测 (见图 8~10), 了解高温下纤维编织网、环氧树脂及基体混凝土的形态。

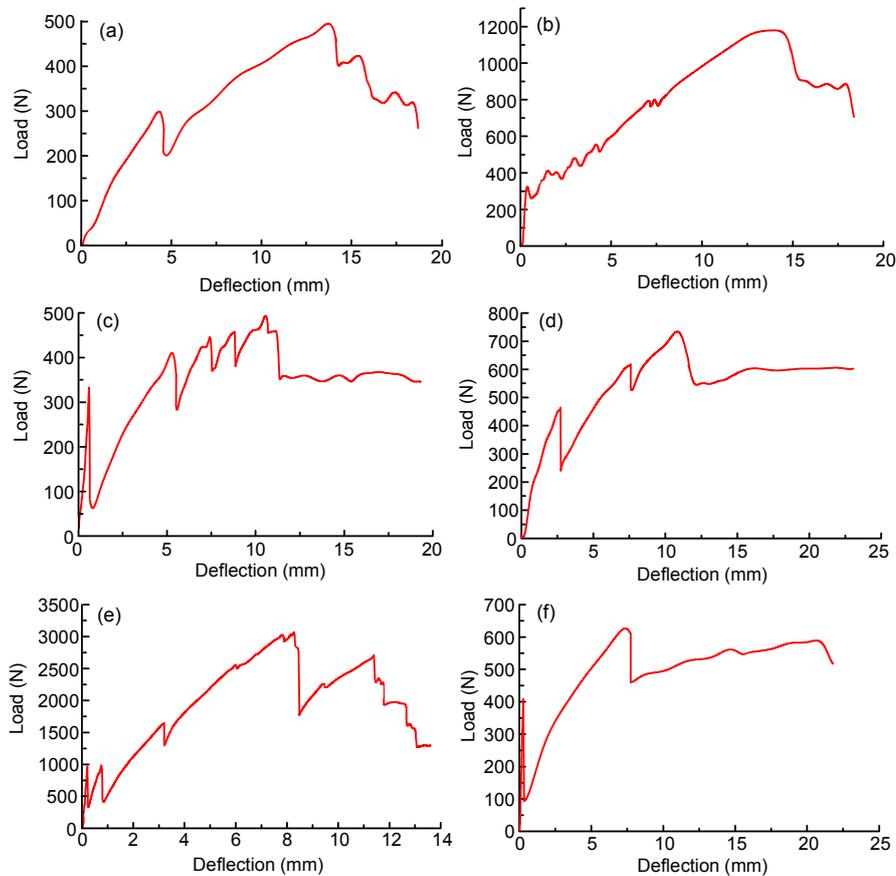
Fig. 4 Load-displacement relation of three-point bending test

(a) Specimen A (room temperature); (b) Specimen B (room temperature); (c) Specimen C (120 °C, 30 min); (d) Specimen D (120 °C, 30 min); (e) Specimen E (120 °C, 30 min); (f) Specimen F (200 °C, 30 min)

The load-midspan displacement curves for the TRC thin plate after treatment at different temperatures and duration times are given in Fig. 4. The first cracking load, ultimate state load, and mid-span deflection under the three-point bending test are shown in Table 5. The temperature and duration time of the process were set on the muffle furnace, and all the

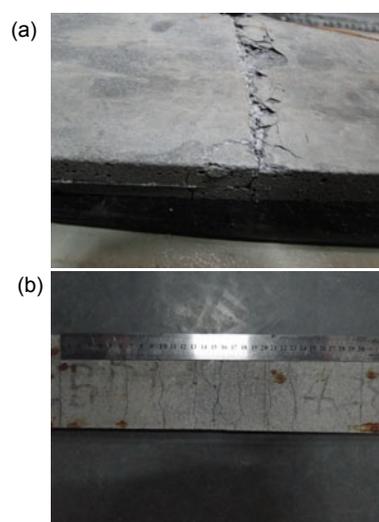
Fig. 5 Failure mode of TRC specimens
(a) Specimen A; (b) Specimen B

Comparison of the bearing capacities between specimens A and B, and C and D showed that under normal temperature and 120 °C, the addition of PP could greatly increase the ultimate out-of-plane load capacity of the thin plate. This was likely to have been the result of the bridging and load transfer effects of the short fibers on the crack development sites. As the first crack of the plate occurred, the bridging effect of the PP fiber may have delayed crack development, reduced the crack width, and optimized the stress transfer between the woven fiber net and the concrete substrate. The failure modes of specimens A and B are shown in Fig. 5. The concrete on the upper edge of the thin plate was crushed. However, the PP fiber mix may have helped the member present a multi-crack failure mode. The fracture interval was between 2 and 4 cm, and the distribution was uniform.

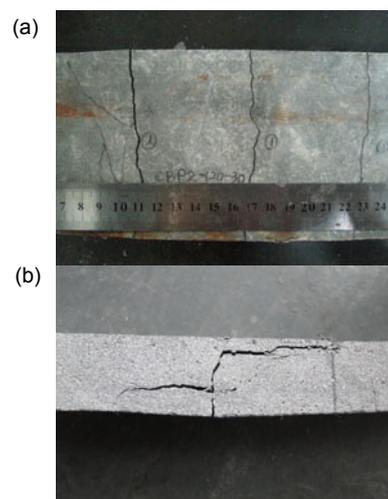
Fig. 6 Failure mode of specimen E
(a) Crack width; (b) Transverse cracks

crushing failure mode. The formed macro-crack number was 3, as specimen E was damaged. The width of the third crack reached 1 mm and a transverse crack was found on the sublayer of the woven fiber net on the side of the specimen. This indicated that the woven fiber net and the concrete substrate had separated. As more loading was added, two horizontal fractures were found, which led finally to shear failure of the specimen. The failure mode is shown in Fig. 6.

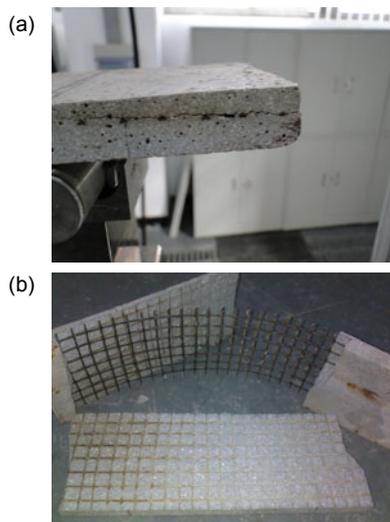
Fig. 7 Degradation of epoxy resin
(a) Epoxy resin interface crack; (b) Adhesion failure

was the early separation of the woven fiber net and the concrete substrate. After treatment at 200 °C for 90 min, the integrity of the thin plate was maintained, but its ultimate out-of-plane load capacity was only 400–500 N. The out-of-plane load capacity of specimen G was lost quickly during the initial stage of the loading, which showed its obvious brittle failure characteristic. Regardless of whether the TRC was mixed with PP fiber, the crack number was 1, as the specimen was damaged. The reasons were: first, the PP fiber had already melted under 200 °C. Thus, the influence of the mixed PP on the out-of-plane load capacity of the plate was not big; second, the color of the epoxy resin on the surface of the woven fiber net had already turned from transparent to deep yellow (Fig. 7). This indicated that the performance of the epoxy resin had already degenerated and the fragility had increased greatly. This damaged the adhesion between the woven fiber net and the concrete substrate, and they quickly became separated.

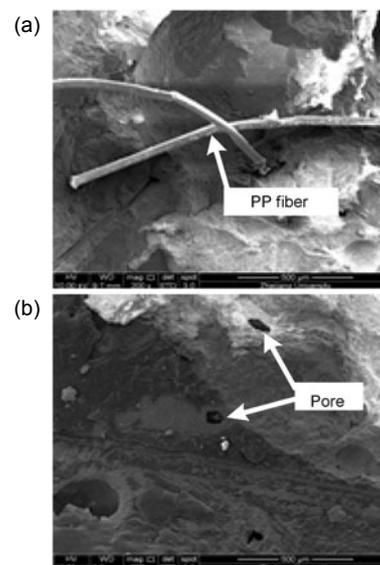
Fig. 8 Polypropylene (PP) fiber after exposure to high temperature for different durations
(a) 200 °C, 30 min; (b) 200 °C, 90 min

To visualize the morphology of the woven fiber net, the epoxy resin, and the concrete substrate at high temperature, an FEI Quanta FEG650 electron microscope and energy disperse spectroscopy were adopted to observe the damaged section of the plate member. The existing form of the PP fiber treated with high temperature is shown in Fig. 8. PP fiber was still found in the thin plate after treatment at 200 °C

for 30 min. The melting point of the PP fiber was 160 °C (Table 4), indicating that the inner temperature of the concrete did not reach 160 °C. However, as the duration of the high temperature reached 90 min, the PP fiber melted, and only a few holes remained (Fig. 8). Thus, if the heating time of a plate member was long, the mixed PP fiber had little influence on the out-of-plane load capacity of the member. However, the porosity of the specimen could be increased with mixed PP fiber, favoring the elimination of vapor and heat from the concrete substrate, thereby reducing pore pressure.

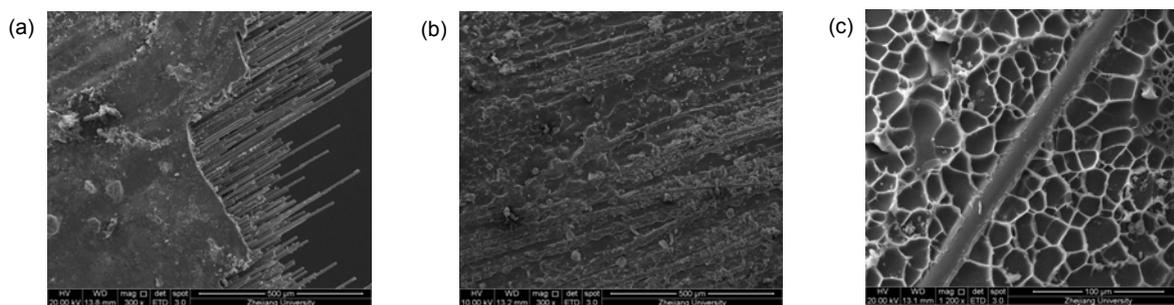
Fig. 9 Epoxy resin on the surface of fiber

(a) Normal temperature; (b) 120 °C, 30 min; (c) 200 °C, 90 min

The morphology of the surface epoxy resin in the woven fiber net after high temperature treatment is shown in Fig. 9. As the temperature and the high temperature duration increased, the morphology of the epoxy resin changed greatly. At 200 °C for 90 min, the surface became uneven, and performance of the specimen was obviously degraded (Fig. 9c). The interfacial condition of the fiber surface and the substrate after treatment at 200 °C for 90 min is shown in Fig. 10. The fragility of the epoxy resin on the fiber net surface increased greatly, and obvious cracking was observed on the epoxy layer of the fiber surface. Unevenness was already apparent at the interface between the fiber and the concrete substrate, which would lead to the easy separation of the plate and a great drop in its out-of-plane load capacity.

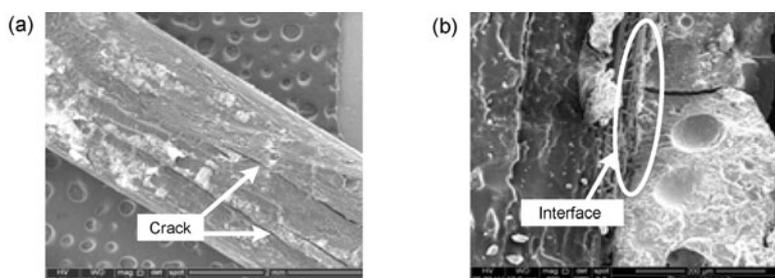
Fig. 10 Interface condition after treatment at a high temperature of 200 °C for 90 min

(a) Cracks in epoxy resin; (b) Separation at the interface
