Failure analysis of a kind of low power connector

ZHOU Yi-lin^{†1}, ZENG Ning¹, XU Liang-jun¹, JÖRGENS Stefan^{†2}

Abstract: A kind of low power connector used e.g. in household appliances was partly burned in routine experiment. The heat sources were four paralleled contacts constructed by springs (Sn/CuSn-alloy) in socket and a plug sheet (Ni/Steel) while mating. The contact interfaces were detected by scanning electronic microscope (SEM) and X-ray energy dispersive spectroscopy (XEDS), obvious wear tracks and various contaminants, including element Si, Al, Na, K, S, Cl, O, etc., were found. The contamination degrees on the four paralleled contacts were different, so that the ratio of average contact resistance on the four contacts was about 5:8:3:1. The maximum contact resistance on contacts of the plug sheet reached 28 Ω . The main failure reasons were fretting and contamination between the contact interfaces. Fretting simulation showed that connection resistance of connectors was raised up, even to ohms level. When the current increased to 5 A, the socket housing was heated and decomposed. By the thermal analysis, it was estimated that the connector would be burned under the

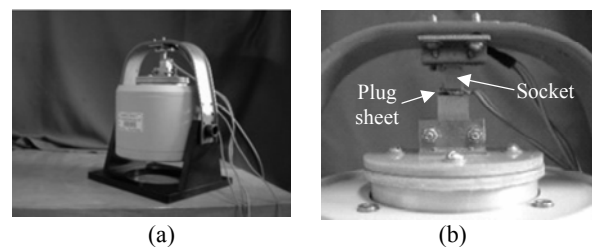
The socket was clamped by a self-made fixture, the plug sheet was fixed on the vibration stage, shown in Fig.10. The amplitude of fretting was 200 μm , controlled by the signal generator. The frequency was 2 Hz. The D.C. current was set at 20 mA. The connection resistance, the total contact resistance of four paralleled contacts, was monitored, shown in Fig.11.

**Fig.10 The vibrator for fretting simulation. (a) The vibration stage; (b) The fixture of socket and the plug sheet**

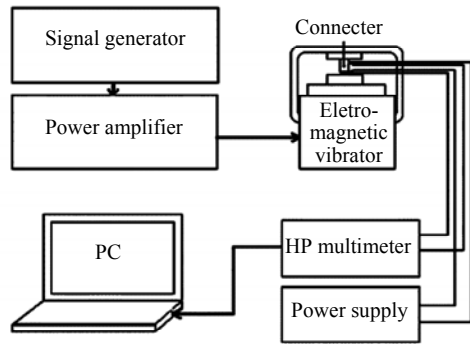
Fig.11 The sketch of vibrator system

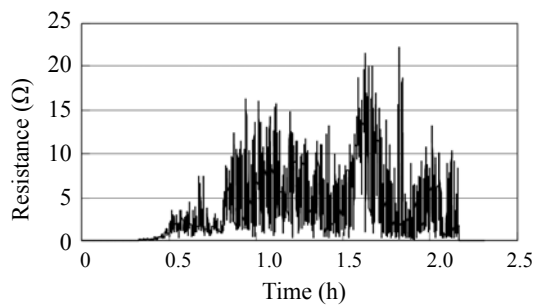
Under 20 mA current, the connection resistance of the connector is shown in Fig.12. The connection resistance increases gradually from 3 m Ω to a balanced value 5 Ω , and fluctuates around this value. The maximum connection resistance reaches 23 Ω .

Fig.12 The connection resistance between Sn/CuSn-alloy-Ni/Steel contact pair for about 2.2 h

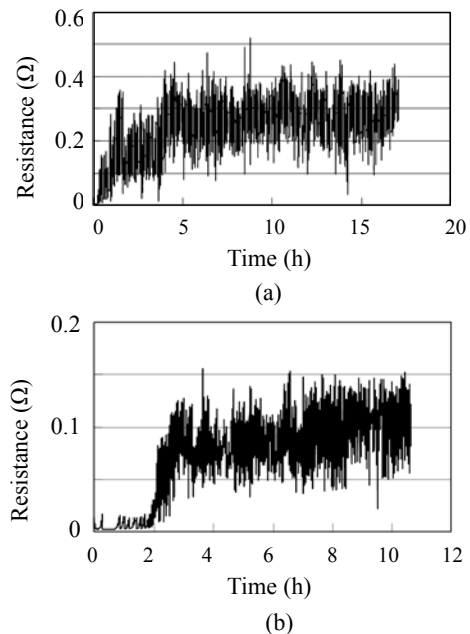
The curves of the connection resistance under 2 A and 6 A currents during fretting are shown in Figs.14a and 14b respectively. From the beginning, the connection resistance increased gradually, which is caused by the accumulated metal oxide produced on all of the four contacts under fretting. Then the connection resistance reached a balanced value and fluctuated around it. That is formed by the integrated effects of both fretting and current. The fretting causes contact resistance to increase, but the insulative oxide can be broken down to lower contact resistance when high current passes through the contacts. Then the oxide is formed continuously, contact resistance increased again cyclically. The balance was kept for more than 10 h.

Fig.14 The connection resistance during fretting. (a) 2 A current; (b) 6 A current

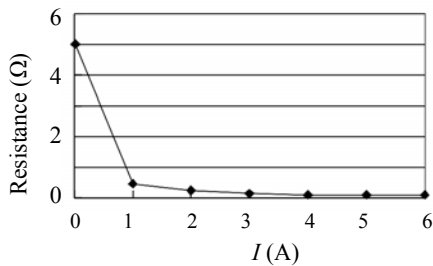
Balanced connection resistance existed under various currents. The relation between balanced connection resistance and currents is shown in Fig. 15. As the current increases from 1 A to 6 A, the balanced connection resistance reduces from 0.45 Ω to 0.1 Ω , but the reduced extent remained smaller. And the time to reach the balanced value was delayed from 50 min to 100 min (Fig. 16). That proves the effect of the current on the reduction of contact resistance was stronger than that of oxide film formed by fretting on the increase of contact resistance.

Fig. 15 The relation between balanced connection resistance and various current

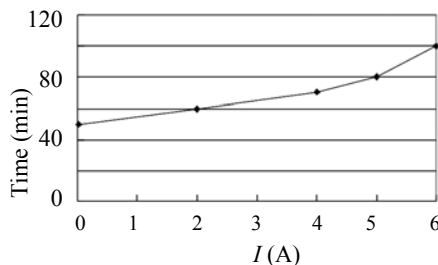
Fig. 16 The time to arrive to the balanced connection resistance under various current

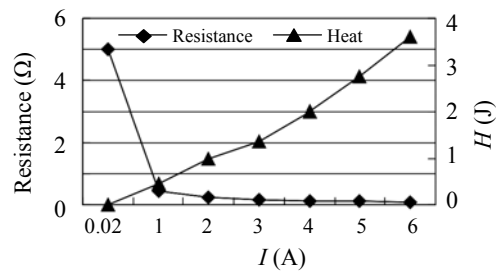
Whether the connectors are burned or not depends on the Joule heat produced from the contacts. Although the connection resistance is reduced as the current increases, the Joule heat, I^2R , increases continuously, shown in Fig. 17.

Fig. 17 Joule heat increases with currents

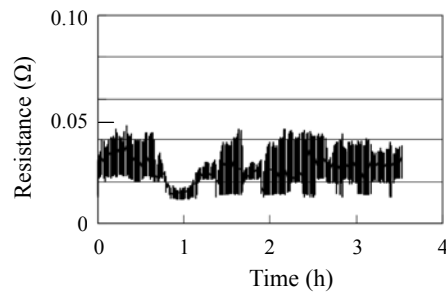
Fig.19 The connection resistance between Ag/CuSn-alloy and Ni/Steel contact pair during fretting under 6 A current

The materials of the springs in the socket and the plug sheet, Sn/CuSn-alloy and Ni/Steel, were non-noble metals, which are easily worn and oxidized during the fretting process to increase the contact resistance. To deal with the fretting failure of connectors, the structures of connectors can be re-designed, such as increase contact force, restrict the micro-motion between contacts, etc. The plating on contacts can be changed to postpone the fretting failure. Silver can be an alternative plating to replace tin plating on the spring contacts in the sockets to reduce the effects of fretting. The connection resistance between Ag/CuSn-alloy and Ni/Steel contact pairs during fretting under 6 A current is shown in Fig.19. Its connection resistance was about 0.03 Ω , much lower than that between Sn/CuSn-alloy and Ni/Steel contact pairs shown in Fig.14b. The reason is that Ag cannot be easily oxidized during fretting.
