## Particle contamination, the disruption of electronic connectors in the signal transmission system<sup>\*</sup>

ZHANG Ji-gao

(Research Lab of Electric Contacts, Beijing University of Posts & Telecommunications, Beijing 100876, China)

**Abstract:** Particle pollution in air, also sometimes known as fine dust contamination, may cause electric contact failure. Recent research further proved that the fine particle is becoming a major disruption of the electronic connectors in signal transmission system. This paper specifies the connector contact in mobile phone application. To study the contact failure of mobile phone, a series of inspections and analytical research methods are introduced. Special features that cause the contact failure are summarized. Particle accumulation is the main problem; organic material such as lactates from sweat of the human body may act as adhesives to stick the separate particles together and make them adhere on the contact surface; chemical properties of dust cause serious local corrosion. The corrosion products may trap the particles and firmly attach on the contact surface; micro motion frequently occurs at the contact interface. Hard particle can b

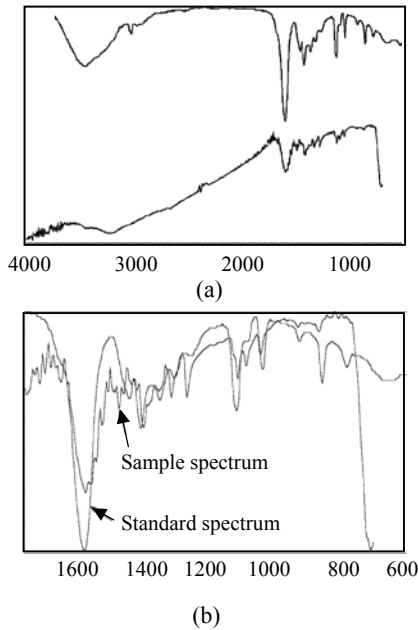
Fig.7 illustrates a comparison of infrared spectrum of tested sample with standard sodium lactate. It shows that the specific peaks of both spectra were highly overlapped.

range, it can be very sticky and act as adhesive. Sodium lactate with low water content, at appropriate temperature may perform higher resistivity and higher adhesive capability. Since lactates are not good insulator, high contact resistance usually happened at the piled contaminants with thickness nearly 1~2 microns.

Fig.7 (a) Full spectrum, upper is standard sodium lactate, lower is testing sample; (b) Specific spectrum, upper is standard sodium lactate, lower one is testing sample.
